## STRESS-CORROSION CRACKING OF ION EXCHANGE RESIN TANK AT SLAC

### Ion-Exchange Tank Failure

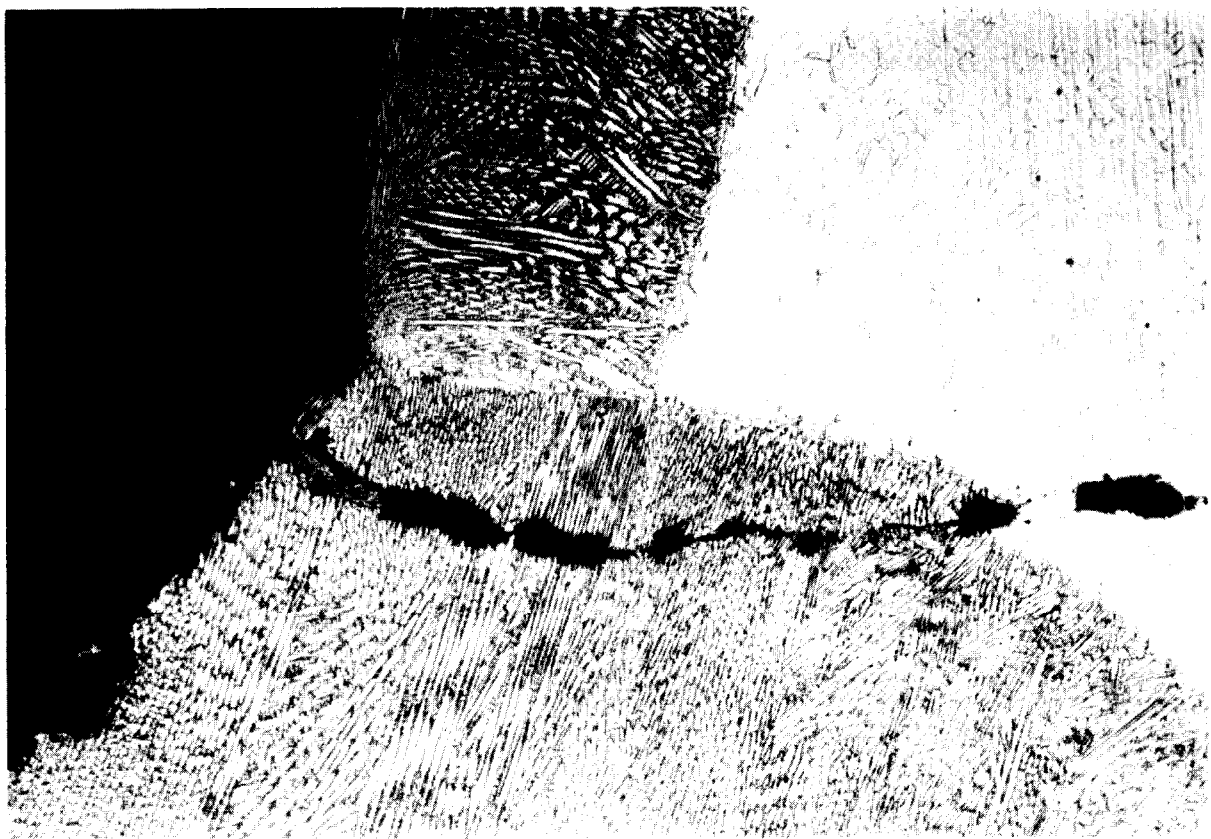
Fig. 1

Figures 1 through 8 illustrate the nature of some of the cracked regions found in this tank. All cracks were closely associated with the base of the inside

Figure 1 shows the start and Fig. 2 the end of a typical crack. When the crack was examined in the field, the tank shell was bowed out and away from the inside of the tank and Fig. 2 illustrates this fact. The geometry of the fitup is such that the tank head could only move in an outward direction caused by the internal pressure of the LCW system. The region marked "Ductile Region" probably tore as system pressure was being applied. The position of this metallographic specimen is near, but not at the original fracture site. The original site probably has some undercutting by the weld bead which would provide an enhanced stress-concentration factor. Figure 3 is a higher-magnification picture of the ductile-fracture area seen in Fig. 2, and clearly shows the numerous branched cracks typical of stress-corrosion cracking. The specimen, at the microscope, and the original photomicrographs show many thin slip lines that parallel the cracks but these may not reproduce well in this report. Slip lines are seen in stainless steel that has been severely overstressed. These lines appear only in the region of the crack. Many other samples from around the tank section and at some distance from the crack were examined and none contained slip lines.

<u>Number</u>	<u>Photo Number</u>	<u>Magnification</u>	
1	HZ-34	85X	Start of stress-corrosion crack at inside surface of tank
2	HZ-36	85X	End of stress-corrosion crack at outside surface of tank
3	HZ-45	680X	Typical branched cracking characteristic of SCC — note slip lines
4	HZ-44	680X	Branched cracking and slip lines
5	HZ-41	340X	Branched cracking in weld area
6	HZ-56	680X	Branched cracking and slip lines near outside surface of tank — Region 2
7	HZ-61	340X	Branched cracking emerging at outside surface of tank — note slip lines
8	HZ-62	680X	Transgranular branch cracks adjacent to main crack

Installation of a welded flange in such a flexible member as the tank head produced a very highly stressed region. A stress relief anneal could have prevented this failure.

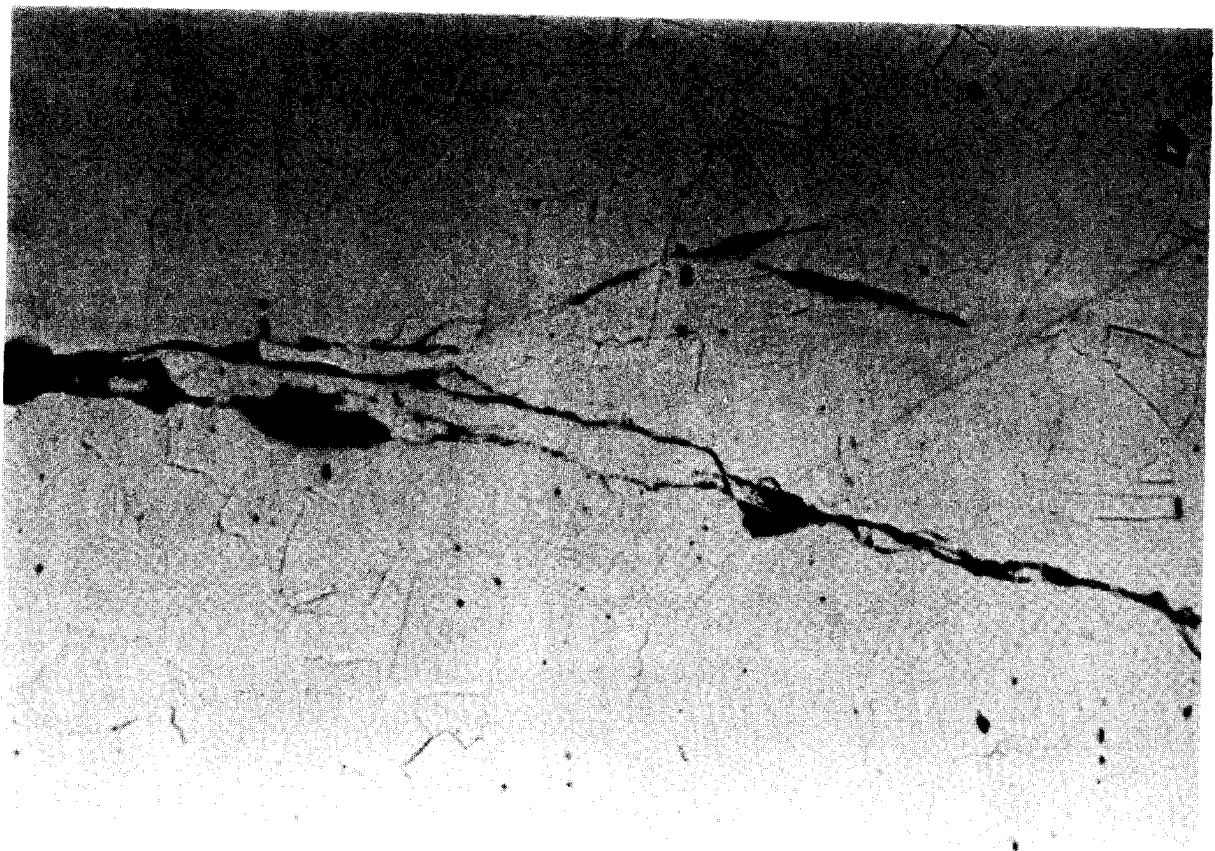
Fig. 4

Figure 4 was obtained next to Fig. 3 and illustrates the branching nature of the crack, as well as numerous slip lines running parallel to the crack.

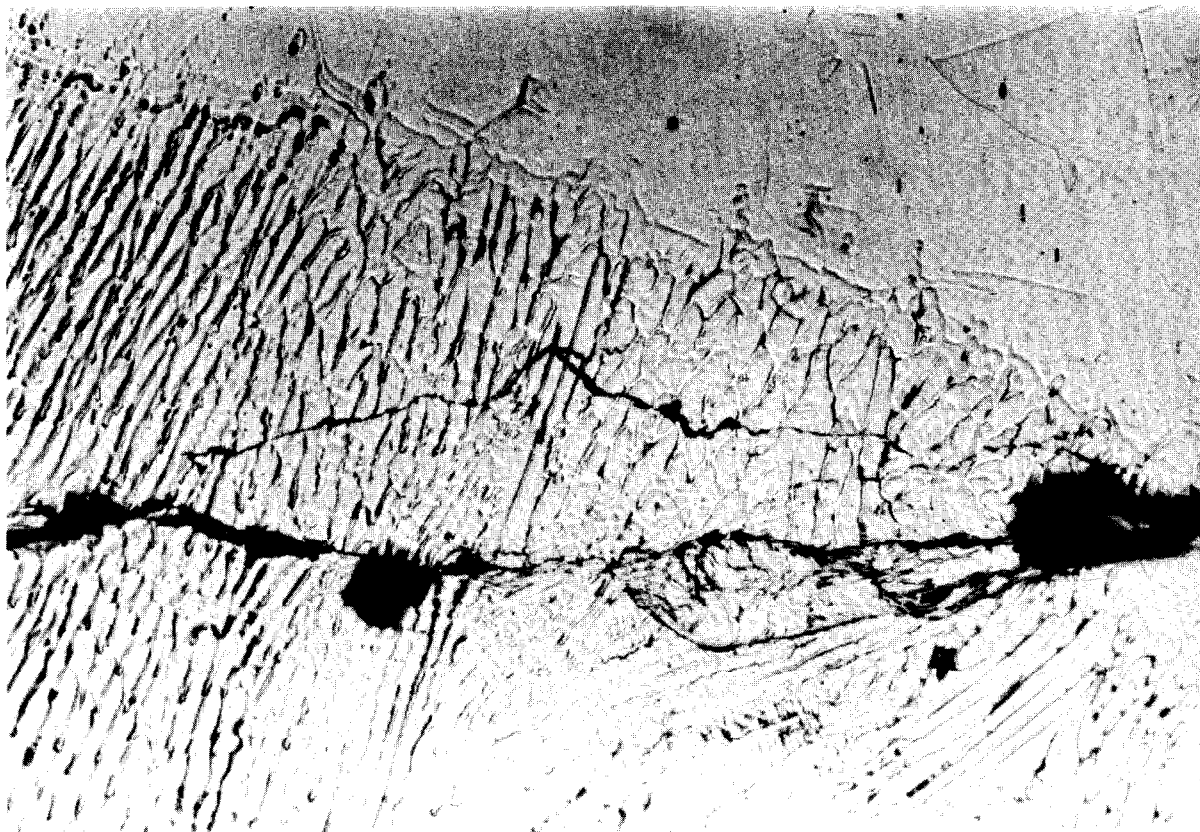
Fig. 5

Figure 5 was obtained in the region where the crack was about to emerge from the weld area seen in Fig. 1. Branching is visible here, too, as it cuts across the two-phased region of "delta ferrite" envelopes surrounding the austenite. This small amount of ferrite, present in all good stainless steel welds, is magnetic and has corrosion resistance equal to the austenite.

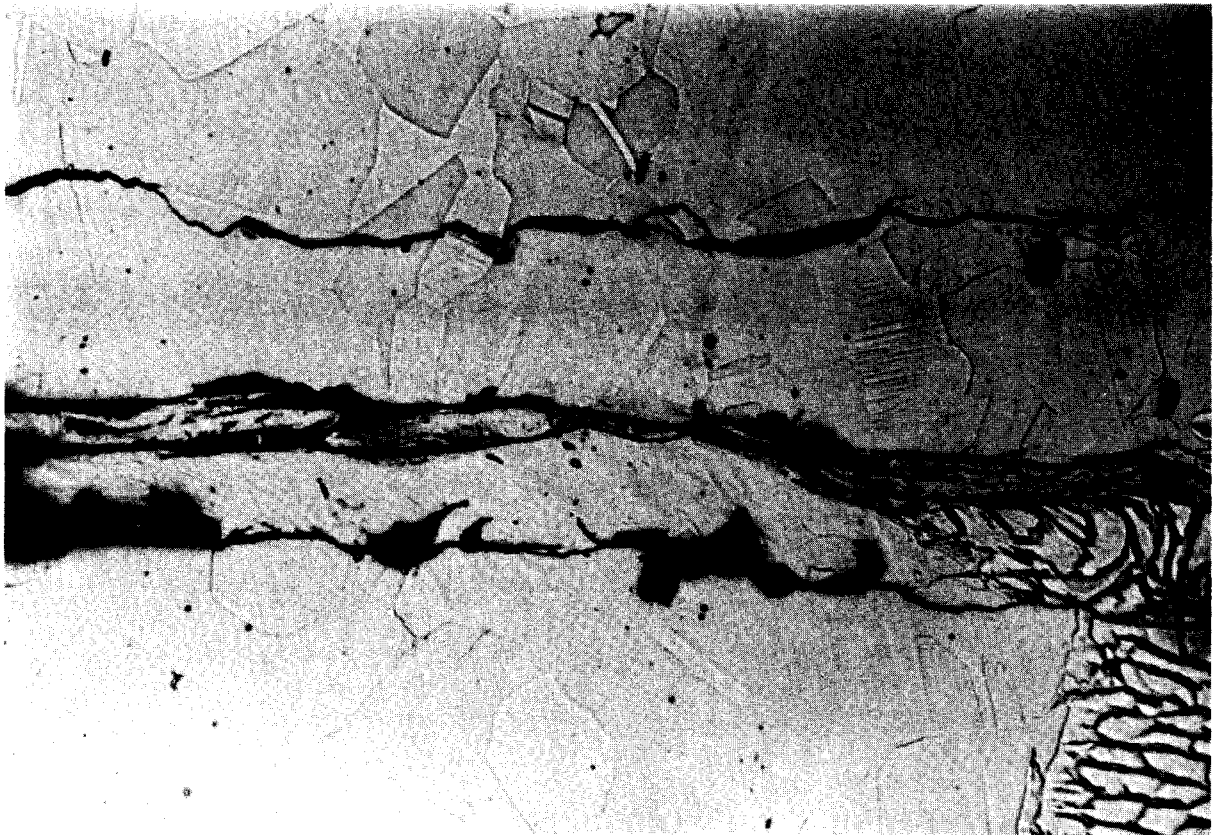
Fig. 6

Three more photomicrographs, from a different area, further illustrate these characteristics of stress-corrosion cracking. Figure 6 shows the many branches of a crack as it terminates in a weld. Figure 7 again illustrates the slip lines that accompany an overstressed section of stainless steel and Fig. 8 shows some side cracks branching from the main crack. The transgranular aspect of this failure mode is shown plainly in this last photo.
