# INVESTIGATION ON MYSTERIOUS LONG-TERM ORBIT DRIFT AT NSLS-II\*

## Abstract

Over a few months in 2018, we observed occasional episodes of relatively quick accumulation of correction strengths for the fast correctors (used by the fast orbit feedback) near Cell 4 (C04) region at NSLS-II Storage Ring. We immediately started investigating the problem, but the cause remained unclear. However, after coming back from the Fall shutdown, we experienced even faster drifts, at a rate of as much as 10 urad per day in terms of orbit kick angle accumulation. The risk of damage on the ring vacuum chambers by the continuing orbit drift without explanation eventually forced us to take emergency study shifts and temporarily lock out the C04 IVU beamline. After extensive investigation by many subsystem experts in Accelerator Division, ruling out many suspicious sources one by one, we were finally able to conclude the cause to be the localized ground motion induced by large temperature jumps of the utility tunnel right underneath the C04 straight section. We report the details of this incident.

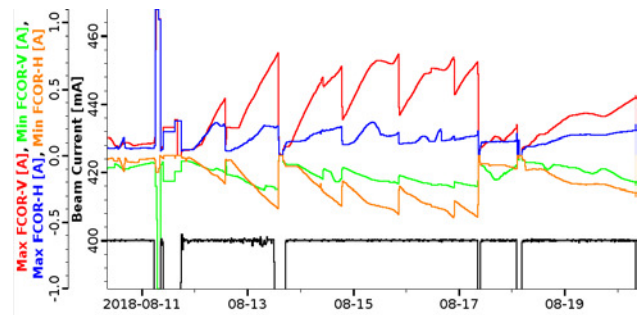
We noticed the first persistent orbit drift around the start of August 12, 2018, by the fact that the correction strengths of the fast correctors, which are automatically controlled by the fast orbit feedback (FOFB) system, were quickly accumulating. The fast correctors are rather weak, having the current range of  $\pm 1$  A with 12 urad/A. This forced us several times to run a shifting program that transfers the fast corrector correction strengths to the slow correctors, shown as the sawtooth behaviors of the maximum and minimum fast corrector strength history in Fig. 1. After about a week, the accumulation speed tapered down. The correction was always the strongest around Cell 4 (C04) straight section,

Figure 1: 10-day history of fast corrector max/min current, starting from August 10, 2018, before the shutdown.

and orbit analyses indicated a potential kick source around the same region. Since the readback for the insertion device (ID) orbit correctors for C04 ID was known to be unreliable, we decided to upgrade the power supply interface during the machine Fall shutdown starting on Aug. 20, 2018, to determine whether one of the ID correctors is the culprit if the same trend returns.

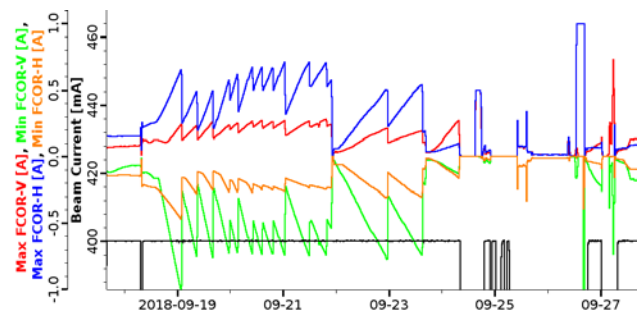
Figure 2: 10-day history of fast corrector max/min current, starting from September 17, 2018, after the shutdown.

When we came back from the shutdown on Sept. 17, 2018, the orbit was stable for one day, until a similar drift reappeared, as shown in Fig. 2. The strength accumulation was even faster than before, requiring more frequent fast-to-slow-corrector shifting operations.

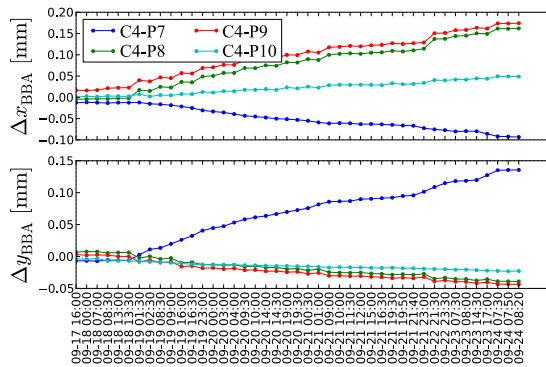
During the course of the investigation, as shown in Fig. 3, we realized that our so-called ID BPM beam-based alignment (BBA) values were drifting by more than 150  $\mu\text{m}$  within a week, our administrative threshold value for resetting the ID BPM BBA values. We will discuss more about ID BPM BBA values later, but these values are supposed to be constant over a long duration and the basis of our active interlock system for equipment protection [2]. Hence, it was deemed too risky to continue operation of C04 ID without knowing why these values were varying this much.

Figure 3: History of C04 ID BPM BBA deviation.

The drifting of the C04 ID BPM BBA values shown in Fig. 3 can be also explained by this girder motion. The BBA values are defined such that, if added to the ID BPM raw position values, ID BPM positions will always lie on the straight orbit drawn between the position readings of the 2 nearest BPMs bounding the ID straight section. This definition corresponds to a special case of dynamically-bounded orbit (DBO) as defined in [3], where the orbit at the 2 bounding BPMs is adjusted to their quadrupole-scan-based BBA values and the IDs in this bounded region are all fully open.

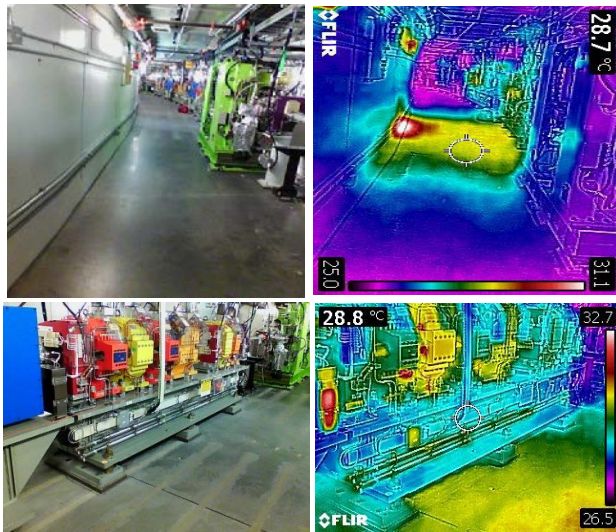
Figure 4: (Left) visible light and (right) infrared images of the section between C04 downstream bending magnet and C04 ID straight, right above the steam tunnel.

Finally, however, the girder alignment survey and thermal image scans of the C04 straight region on 09/26 revealed the root cause. As shown in Fig. 4, the floor temperature of C03 Girder 6, right next to and upstream of the

straight section, was locally elevated. The typical floor temperature in the storage ring tunnel is 25–26 °C, while the hottest area in front of the C03G6 girder was 34 °C (measured with a hand-held IR thermometer). Although not known to many people at the time, under this girder was a steam tunnel that brings in hot water for the whole facility. The visible light and infrared images of the tunnel are shown in Fig. 5. Utility Group found that the belt for an exhaust fan in the tunnel was broken and fixed it on Sept. 18. According to the history shown on Fig. 6, the tunnel temperature was hovering around 150 °F when discovered. After the fix, the temperature dropped quickly to 110 °F within a few hours. This sudden change in temperature apparently set off the ground motion. Table 1 shows the girder motion around this region on 9/25/2018, compared to the survey data during Fall 2016. The fiducials moved as much as by 270  $\mu$ m (H) and 330  $\mu$ m (V).

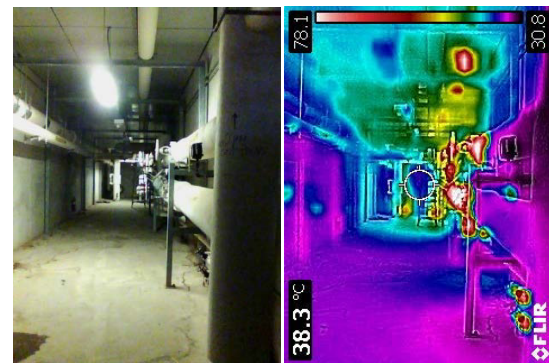
Figure 5: (Left) visible light and (right) infrared images of the steam tunnel below the C04 ID straight.

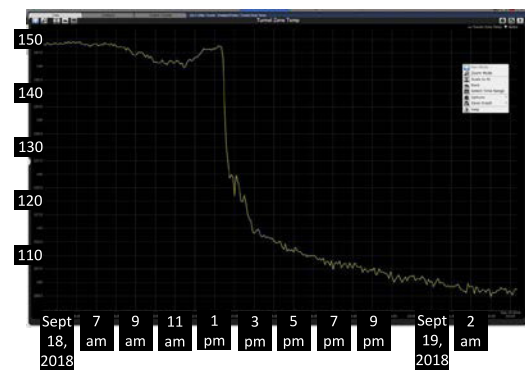
Figure 6: Steam tunnel temperature history on 09/18/2018 when the broken exhaust fan belt was found and fixed.

The timing of the temperature drop and the onset of the fast corrector accumulation trend exactly matched. Looking back further, there was a sharp temperature rise near the end of Aug. 11, as shown in Fig. 7. This was probably when the fan failed, and responsible for the fast corrector drift before the shutdown. Note that the amount of temperature jump is smaller in the August event than in the September event, which corroborates well with the accumulation speed difference. As Fig. 8 shows, the tunnel temperature was gradually increasing since April, yet there was no discernable fast corrector trend. From this, we can infer that the gradual temperature change does not cause a fast large floor motion, but sudden change does.

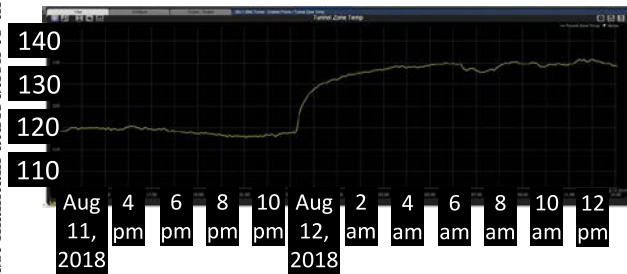
Figure 7: Steam tunnel temperature history in °F on 08/12 2018 when the exhaust fan belt apparently broke.

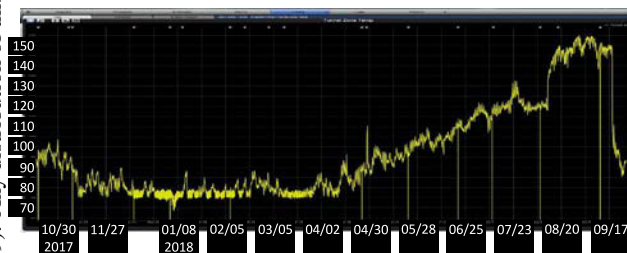
Figure 8: Steam tunnel temperature history in °F between October 2017 and September 2018

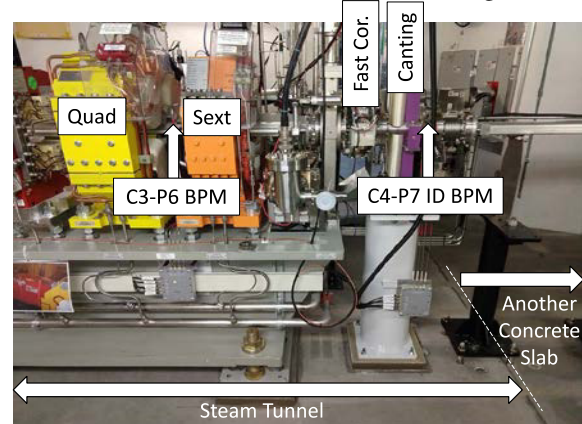
The most important characteristic of this orbit is that it stays constant as long as the 2 bounding BPMs and those within the bounded region, i.e., ID BPMs, are not physically moving and there is no change in transverse kicks within the bounded region. If the orbit is not constant as was the case in this incident, at least one BPM must be moving or the kick angle by one magnetic element must be changing. In this case, as Fig. 9 shows, one of the bounding BPMs (C3-P6) and one of the ID BPMs (C4-P7), located

right above the steam tunnel, must have been moving. The rest of the ID BPMs (C4-P8, C4-P9, C4-P10) are located on a different concrete slab to the right of the black seam (along the white dotted line). Using the unique characteristic of ID BPM BBA, combined with the reasonable assumption that C4-P9, C4-P10 and C4-P1 were much less affected by this thermal event, we can estimate the physical motion of C3-P6 and C4-P7 since the last ID BPM BBA update (within a week), by fitting a straight line to the 3 BPM positions, extending it to P6 and P7, and calculating deviations. The estimated result is shown in Fig. 10.

Figure 9: Relative positions of one ID BPM (C4-P7), one bounding BPM (C3-P6), different types of magnets, and the steam tunnel (extending beyond the left edge and separated by 635-mm-thick accelerator tunnel concrete floor). C04 ID is located on the right side of photo.

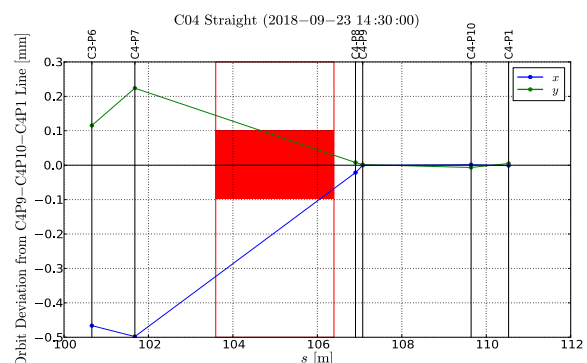
Figure 10: Estimated physical BPM motions for C3-P6 and C4-P7 assuming C4-P9, C4-P10 and C4-P1 were stable (C04 ID represented by red box).
