NSLS-II BEAM APERTURE SLIT VIBRATION STUDIES

C. Spataro, C. Amundsen, H. Bassan, S. Sharma
Brookhaven National Laboratory, Upton, NY 11973 USA

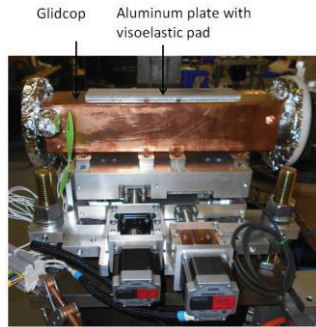
An experiment was then performed in which a viscoelastic pad was added to the top of the slit to help dampen

out the vibrations (Fig. 2). This reduced the peak vibration levels but at the expense of broadening the bandwidth. The runaway vibration problem was still not resolved.

Figure 2: Slit assembly with viscoelastic pad.

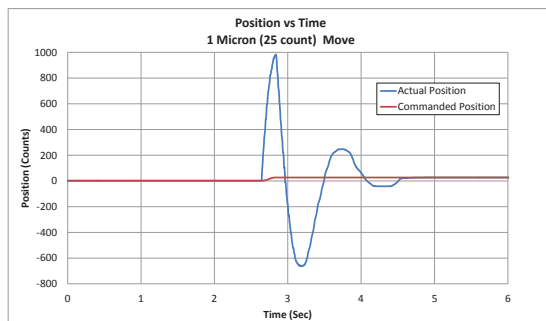
Current tuning of the motors followed by the PID loop tuning was done to get a better response. It was found that when moving the motor by a small number of encoder counts (for instance, 25 counts, which is equivalent 1 micron in position) the motor actually moved up and down over one thousand counts (± 40 microns) before arriving to the desired position (Fig. 4).

Figure 4: Actual and Commanded Position vs Time.

The motors were re-tuned and this reduced the unwanted excursion to 14 microns, which is still large but much better than the original tuning.

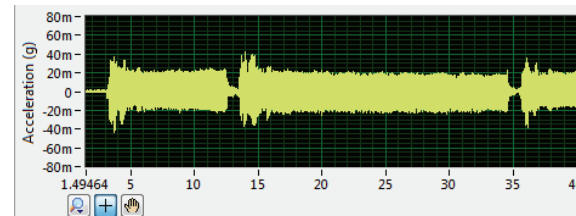
A large factor in the vibration was the default motor velocity. Tests were performed at various velocities. It was found that there was a linear correlation between vibration levels and the default motor velocity. After numerous rounds of tests, a reduced velocity of 1/3 of the default velocity was deemed to be a good compromise which reduced the vibration levels by a factor of three (Fig. 5 and 6).

Figure 5: Acceleration vs Time - Default Velocity.

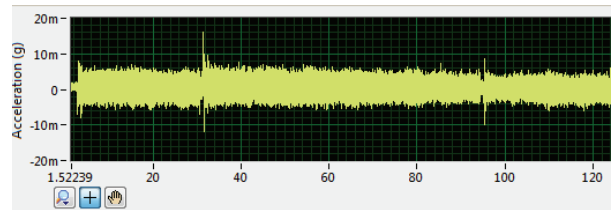
Figure 6: Acceleration vs Time - 1/3 Default velocity.

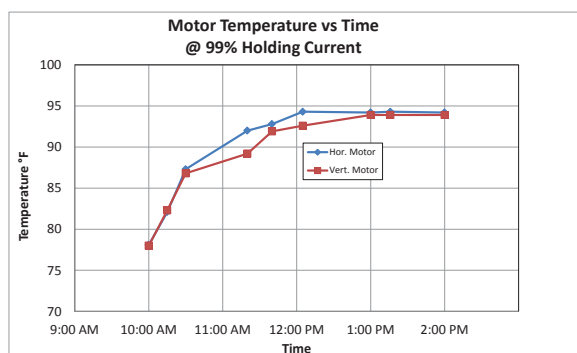
A holding current vs temperature test was performed. The holding currents for both motors were set to 99% of the nominal and monitored for over 4 hours (Fig. 7).

Figure 7: Motor Temperature vs Time.

Temperatures reached equilibrium within two hours and were within specifications. This meant that the holding current could be increased without overheating the motors.

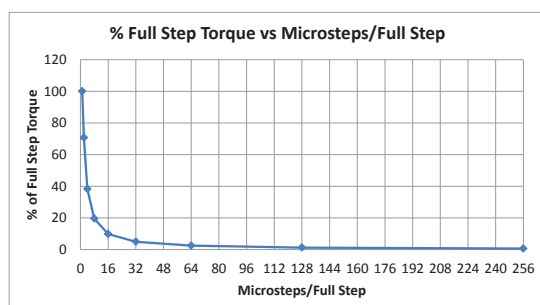
The intermittent nature of the problem is likely to be caused by the reduction in the motor torque when microstepping is used. At the 32 usteps/step setting of the motor, the torque drops to 5% of its rated value (Fig. 8).

Figure 8: % Full Step Torque vs Microsteps/Step.

Depending on the exact position in relation to the motor steps, the torque will vary, so in some micro-stepping positions the torque is higher and the motor does not squeal, where as in other positions, the torque is lower and the motor starts to squeal. While reduced torque has been established as the cause of motor squealing, the sequence of events in terms of motor current, pulse counts, and position, is still under investigation.

It is now planned to increase the holding current and reduce the number of micro-steps for the inclined-axis motor. If the motor squealing persists then 90° worm-gear reducers will be used to increase applied torque to the stages.
