Analysis of Old Copper Synchrotron Light Absorbers from the Stanford Positron
Electron Accelerating Ring

Sara R Marshall

Stanford Linear Accelerator Center

August 3, 2005

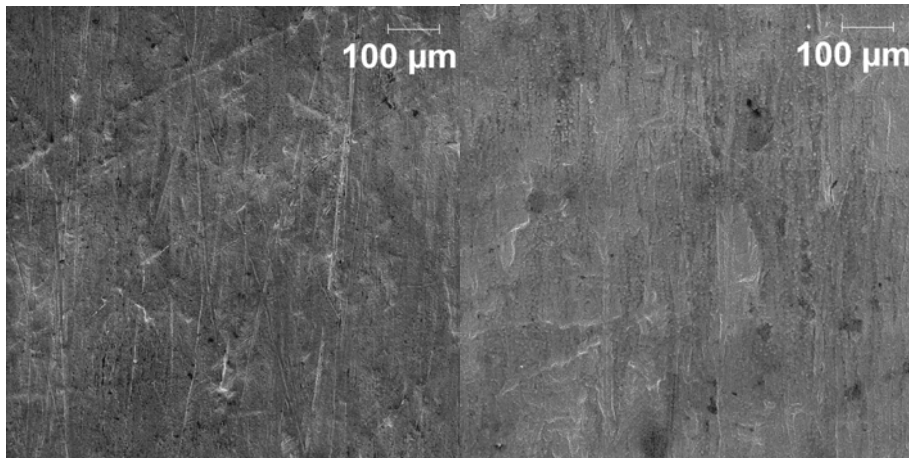
The three observation techniques each gave a snapshot of the mechanical and thermal damage withstood by the absorber. The SE method showed extensive surface scratches on the control and the experimental samples (see Figure 2). At 1000x magnification, the experimental sample showed heavy grooves along the surface. Figure 3 compares the control sample surface to the experimental sample surface at this magnification.

Figure 2: SEM image of surface scratches on both samples, control (left) and experimental (right) at 100x magnification

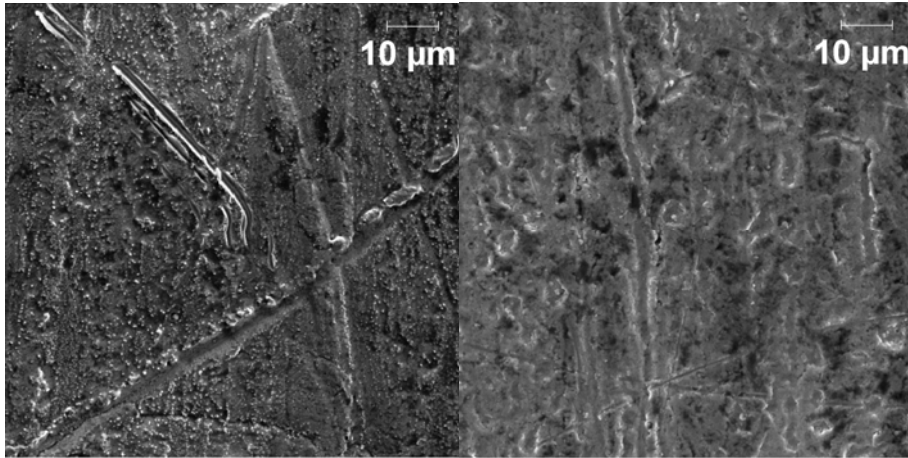
In order for OFE copper to fail, extensive grain movement must occur. When individual grains move within a material, they push into each other. Often the force causes the grains to slip and pull apart from one another. This movement results in the cracks characteristic of failure. When intense heat is added to the system, the grains begin to fuse together, leaving behind larger and fewer grains. This grain growth weakens the material as there are fewer grains to support the structure. The investigation of the BL10 absorber showed evidence of high grain activity. Comparing the control to the experimental sample in Figure 3, it is clear that the structure of the copper changed during its exposure to the electron beam.

Figure 3: SEM image of outer surface of samples at 1000x magnification. Experimental (right) shows grain movement and structure change.

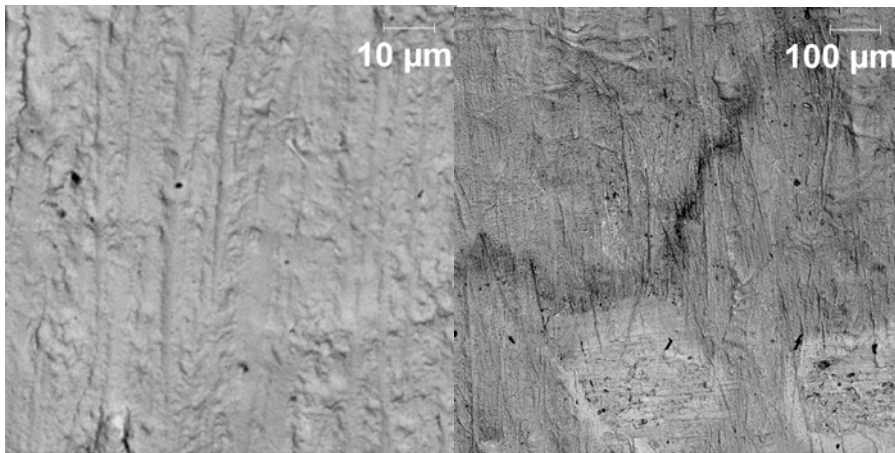
Figure 4 displays the surface of each sample using the BE technique. The BE method constructs an image of the surface of a sample according to atomic number, as opposed to the SE method, which builds an image based on topography.

Figure 4: BE image of sample surfaces. Control (left) at 1000x magnification. Experimental (right) at 100x magnification. Experimental shows greater color change.

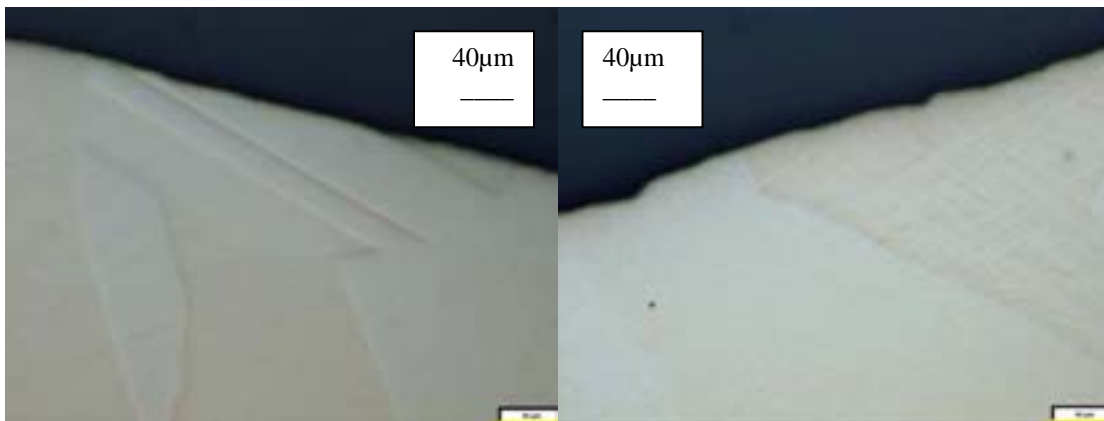
The outer edge of each sample was observed using the optical microscope. Figure 5 illustrates the mechanical damage sustained by the sample exposed to the intensity of the electron beam.

Despite the surface scratches, distinct grooves can be seen in the experimental sample (see Figure 5). These features could be deeper surface scratches, or could be the result of grain separation. But since these grooves do not seem to occur along grain boundaries, they may be deeper surface scratches.

Figure 5: Outer edge of samples seen through optical microscope at 200x magnification. Control (left) shows a smoother edge than experimental (right).

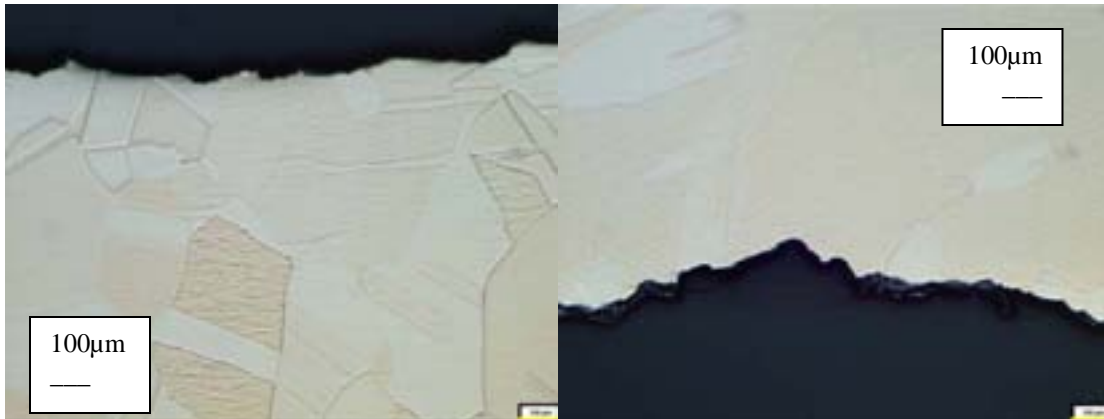
Figure 6 displays the edge of the water cooling passage of the absorber. Each sample showed heavy indentation. The extent of this mechanical damage for each absorber is listed in Table 3. Figure 7 shows the overall cross-section of the experimental sample.

An unexpected result of the absorber usage was the significant corrosion experienced by the inner surface of the tube. This corrosion could be the result of fast flowing or stagnant water. According to an outside study [3], when oxides form on the copper surface and carbon dioxide is present in the water, the CO_2 forms an acid that breaks down into hydrogen atoms and HCO_3^- . The hydrogen atoms react with the oxygen atoms on the surface of the copper to form water. The copper dissolves and the process continues. In addition, the water flowing through the far BL10 tube ran with a velocity of 22.1 ft/s. Typically, the flow velocity is set at 15 ft/s to provide a high heat transfer coefficient and reduced cavitation. The velocities experienced by these absorbers fall in the undesired range. At these speeds, the copper tends to corrode at a faster rate than a normal absorber.

Figure 6: Inner edge of absorber at 25x magnification showing water corrosion. The experimental (right) shows greater damage.

One way to prevent the copper from severely corroding would be to slowly circulate the water through the absorbers during shutdown periods. This would help prevent stagnation. Another way would be to keep the velocities of the water at reasonable levels during each run. Taking an unused SPEAR3 absorber and subjecting it to controlled high flow velocities as well as stagnant water would provide additional information as to the severity of these problems under optimal operating conditions.

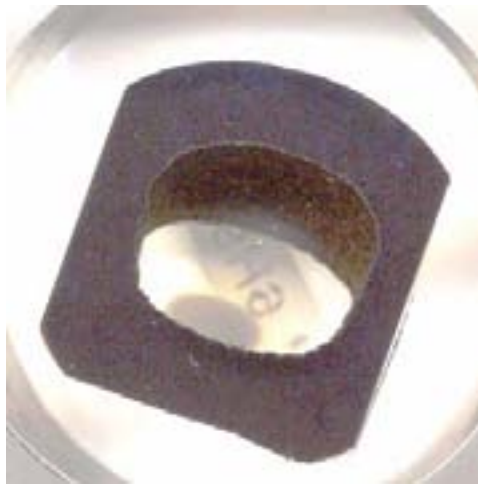
Figure 7: Cross-section of experimental sample. Corrosion is evident along the inner edge of the section. Figure 6 experimental sample enlarges this section. Image enlarged 2.5 times.

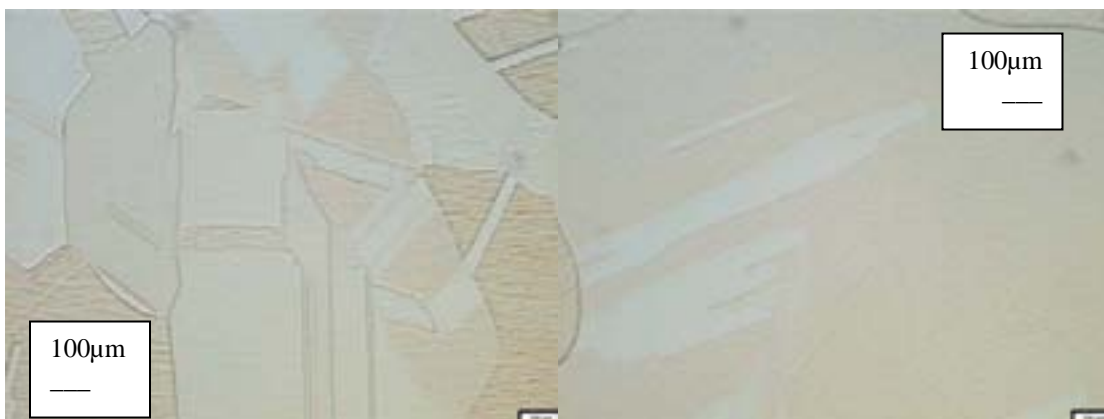
Using the optical microscope, grain structure was observed. Figure 8 illustrates the effect of heating on water-cooled OFE copper. The experimental sample sustained substantial grain growth and thus thermal damage.

The experimental sample experienced substantial grain growth during its time in operation, as evidenced by Figure 8. As copper is formed into a tube, grains break up, leaving vast amounts of small grains. As a result of this work-hardening, the material strengthens. Heat undoes this hardening, fusing grains together.

Figure 8: Grain structure of samples at 25x magnification. Control (left) has an overall smaller grain size than the experimental sample (right).

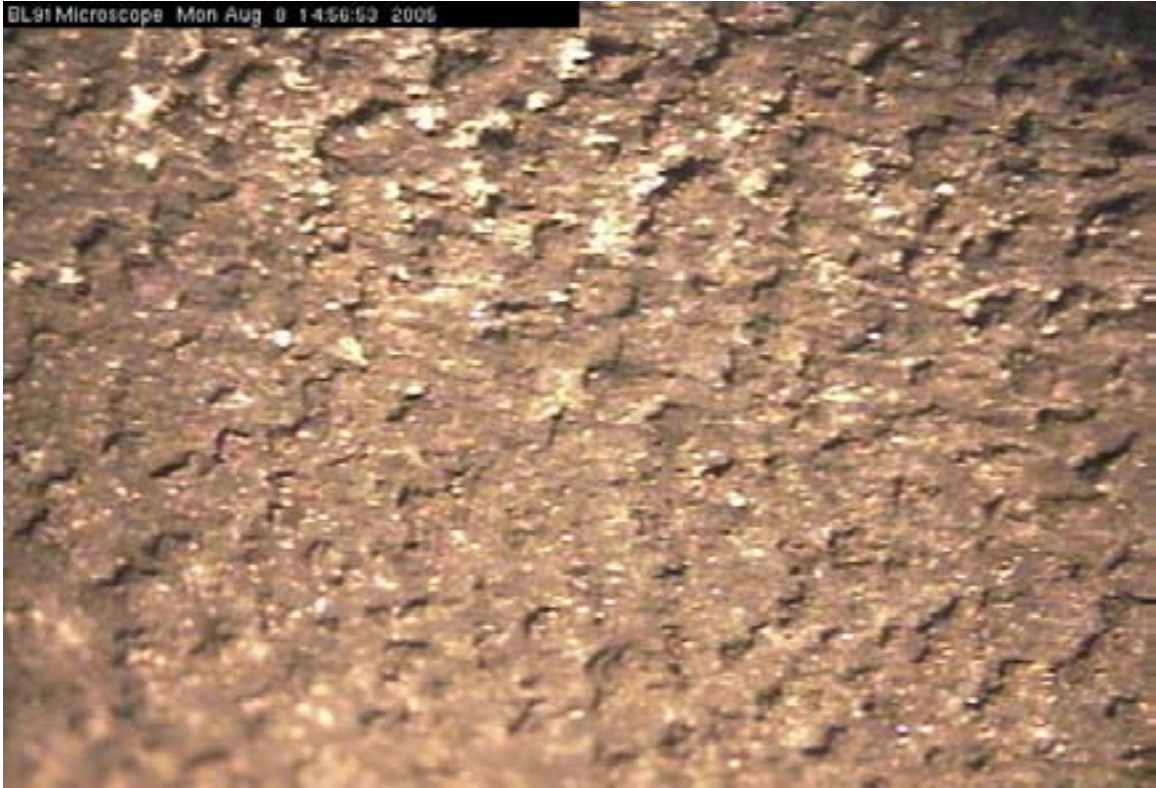
Figure 9 illustrates the plating discovered on the inner surface of the BL10 near absorber. Plating of this type was found on each absorber studied.

Interestingly, the absorbers from BL10 and 11 appear to have material deposited inside the tubes. Before use, the BL11 absorbers were gun-bored with a 0.25" diameter. As seen from Table 3, the diameters of these samples decreased, indicating that material was deposited and plated to the inside of the tube during use. This plating can be seen

along the inside of each tube (see Figure 9). The composition of the deposit was found to be copper oxide. An EDS test performed on the inner surface showed high levels of oxygen and copper. This indicates that the high velocity of the water forced some of the corroded material onto the walls of the water passage.

Figure 9: Image taken from BL9-1 microscope showing black deposit on water cooling passage, 12.5x magnification.
