HISTORY OF CRYOMODULE REPAIRS AT SNS

M. Howell[#], R. Afanador, B. DeGraff, M. Doleans, D. Douglas, B. S. Hannah, S-H. Kim, C. McMahan, T. Neustadt, S. Ottaway, J. Saunders, P.V. Tyagi, D. Vandygriff
ORNL, Oak Ridge, TN 377831, USA

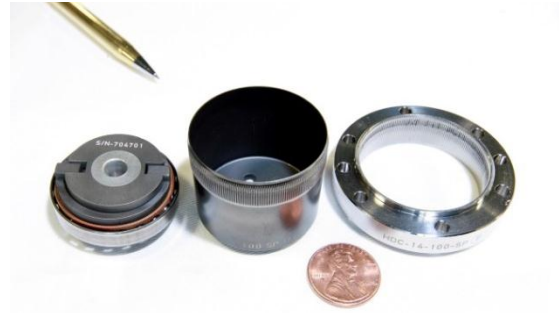
Repairs to the cryomodules have been required to correct failures of the stepper motor and harmonic drives and also to correct abnormal or excessive vibration of a cavity. The failures of the drives and motors can usually be attributed to normal operating wear. Fig. 2 shows a harmonic drive with excessive wear. Irregular or excessive vibration has been witnessed during cavity operation in a few cavities. This vibration is due to a worn harmonic drive or a loosened mechanical connection between the tuner and the cavity. This vibration was corrected by either replacing the harmonic drive or by tightening the tuner mount to the cavity.

Figure 2: Harmonic Drive Assembly.

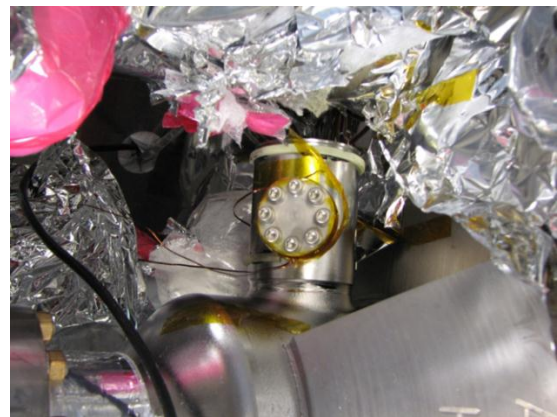
About 15 % of installed cavities in the SNS SCL are showing abnormal signals through HOM feedthroughs while running with RF only. All attenuators for the HOM signals were damaged in 1 year of operation. Observations and physical conditions near the HOM couplers imply that HOM coupler failures and/or degradations seem to be a result of electron activities originated by combinations of multiple causes such as electromagnetic field at the HOM coupler, multipacting, field emission, and even a gas discharge with fundamental accelerating mode. A few cavities were inoperable due to large coupling with the fundamental accelerating mode [5]. In 2007, the SNS re-evaluated the HOM characteristics including dangerous HOM modes measurement for all installed cavities. It was concluded that HOM couplers are not needed for the SNS and it was decided to remove HOM couplers when cryomodules are taken out of the tunnel for repairs. Four cryomodules were taken out of the tunnel so far for various repairs and leaks were detected from half of the HOM feedthroughs. Fig. 3 shows a blanked off HOM feedthrough port after the repair was conducted.

Figure 3: Blanked HOM Feedthrough Port.

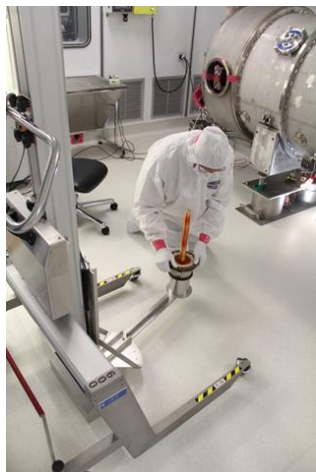
Two cavities have had leaks at the fundamental power coupler (FPC) window. These leaks are thought to have originated during an errant beam event in 2009. This did not result in catastrophic failure but rather resulted in a leak of approximately 10^{-6} torr l/s. As a result of forming

Figure 4: FPC Inner Conductor Replacement.

these leaks, the cryomodules were removed from the tunnel for repair. Replacing the inner conductor of the coupler which contains the coupler window was conducted inside the class 100 area of the clean room. Fig. 4 shows a picture of the coupler replacement in progress. The cryomodules have been returned to service and the performance of the cavities was restored to the original condition.

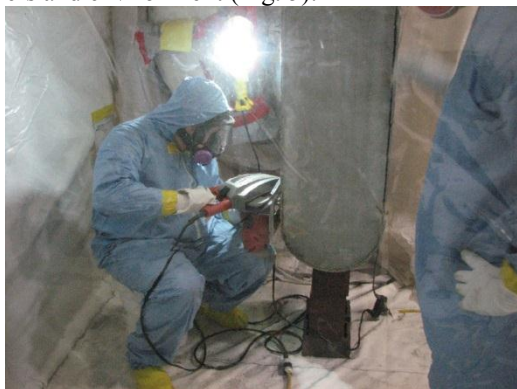
The original cryomodule design for SNS included many in process diodes for accurate temperature measurement. During installation, the ceramic portion of the cold feedthroughs was damaged during welding. As a result, repairs were conducted by cutting through the insulating vacuum boundary and thermal shield to access the diodes. The cold feedthroughs were removed and replaced by surface mounted diodes. These surface mounted diodes have given reliable temperature feedback and operations utilizing these readings have been successful. While conducting these repairs, extra care had to be taken while cutting and grinding on activated cryomodule components. These repairs were conducted in a tent with the personnel wearing protective clothing and full face respirators. A radioactive work permit (RWP) was developed and radiation protection personnel were constantly monitoring the work to ensure safety of the workers and environment (Fig. 5).

Figure 5: Cryomodule Repair under RWP.
