Study the Z-plane strip capacitance

Office of Science, Science Undergraduate Laboratory Internship

Stanford Linear Accelerator Center

August 4th, 2005

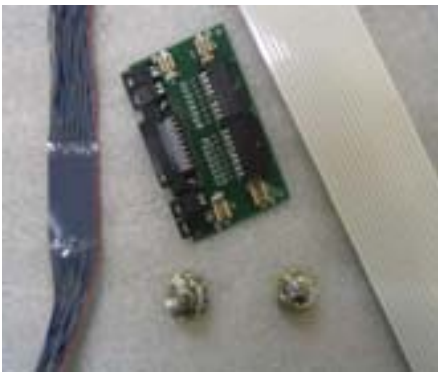
Figure 1 shows the transition board that takes in the white ribbon cable from the Z-plane, a 16 channel blue & white signal cable and 2 12-position single pole rotary switches

Figure 1 shows most of the materials that were used to build the box. We first strip the insulation off the blue and white signal cable and determine which color wires carry the signal and which color wires act as ground. After some testing, it is determined that the white color wires are the signal wires, and now, we needed to figure out how to solder to solder on 16

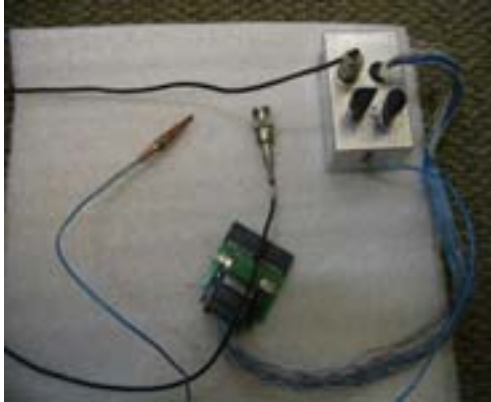
Figure 2 shows the complete box, with the 16 channel signal cable connected to the transition board, the blue wire with the alligator clip that connects to the ground plane, and the black wire which connects from an out BNC connector to the capacitance meter

Figure 2 shows the final picture of the box, with all its components. After the box has been completed, we needed to figure out a convention on how to rotate the switch to swap between channels 1 -16. Since 11 signal wires are connected to one switch, channels 1 – 11 can be accessed by rotating switch A

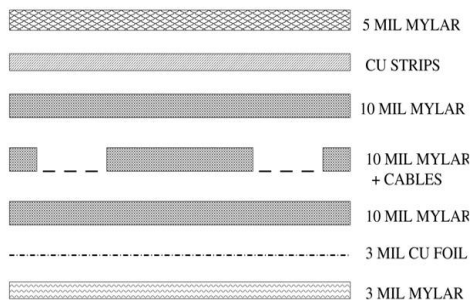
Figure 3: Detailed make up of the Z-plane

film. We first placed the 3 Mil Mylar adhesive side up, then placed a Cu Foil on top of the mylar. We then added a 10 Mil mylar adhesive side face down, another 10 Mil mylar adhesive side face down with holes, and 2 ribbon cables with solder on them at 8 different wires at 8 spots. Therefore, each cable had 8 solder spots on 8 different wires (1 solder spot per wire), and these solder spots matched the holes in the 10 mil mylar. Then, we added Cu strips

on top of the 10 Mil mylar film with holes, so that we could feel the solder spots from the cable to the strips. We then carefully cut out the Cu strip just enough so that the solder spot passes through the strip, and then we melted the solder spot onto the Cu strip. The ribbon cable was now soldered onto the Cu strip, and we added another 5 mil mylar adhesive side face down on top of the Cu strip to protect the strip (Figure 4). We now needed to take all the air out from the Z-plane, so we used this new process of thermal vacuum lamination to suck all the air out from the plane.

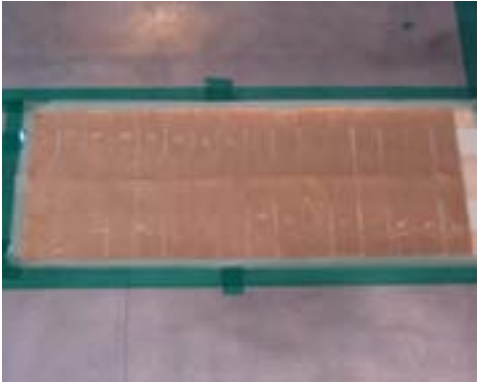
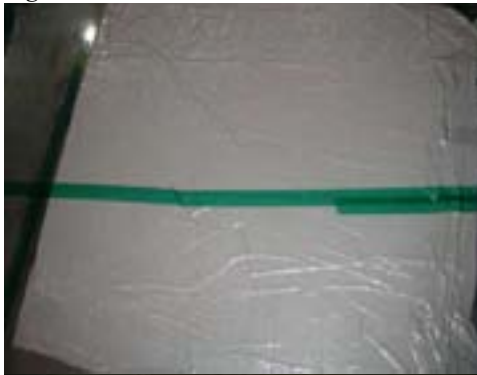
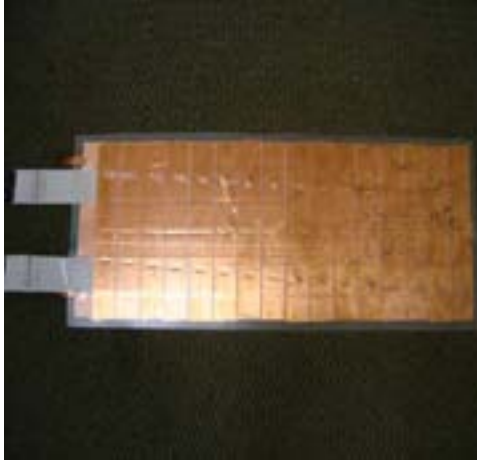
Figure 4

Figure 4, 5, 6: Z-plane before cloth was put on; Z-plane covered in cloth and taped to make it air tight; Z-plane after the thermal vacuum lamination process

We covered the entire Z-plane with a large piece of cloth, and and taped the cloth to the surface so that the Z-plane is air-tight (Figure 5). Before we placed the cloth, we inserted a small tube through a hole in the machine so that the vacuum could suck all the air from the region, and it would travel through that tube. After letting the vacuum runs for about 3 hours, we carefully opened up the Z-plane again, and cut off the extra side edges of the mylar (which had now formed a covering over the strips and the plane). Our Z-plane was finally ready. Figure 6 shows a picture of the Z-plane after it was completed.

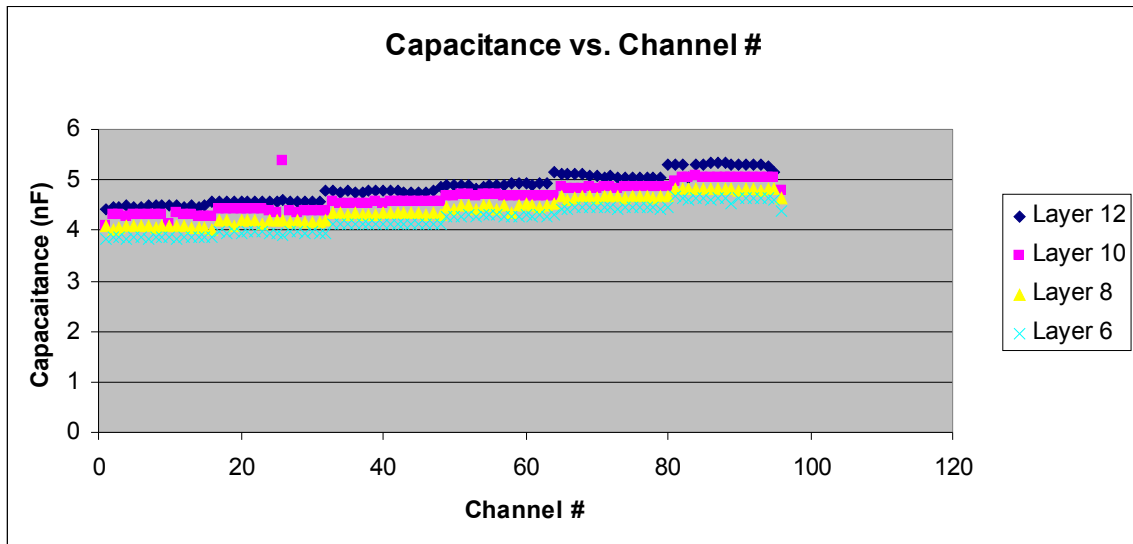
Picture1 1Capacitance vs. Channel #

took hand-by-hand measurements of 12 Z-planes, and the graph below shows the capacitance (in nF) as a function of channel number for 4 of the 12 Z-planes. This graph proves that our theoretical value of $C \approx 4.55 \text{ nF}$ is a good approximation for the capacitance, since most of the capacitance values for these 384 strips (4 planes x 96 strips) lies close it.

This graph also proves our suspicions that the cable length does affect the capacitance. Since the length of the cable is equal for 16 strips, and then increases for the 17th one, it makes sense that the capacitance stays constant for the first 16 channels and then increases for the 17th one.

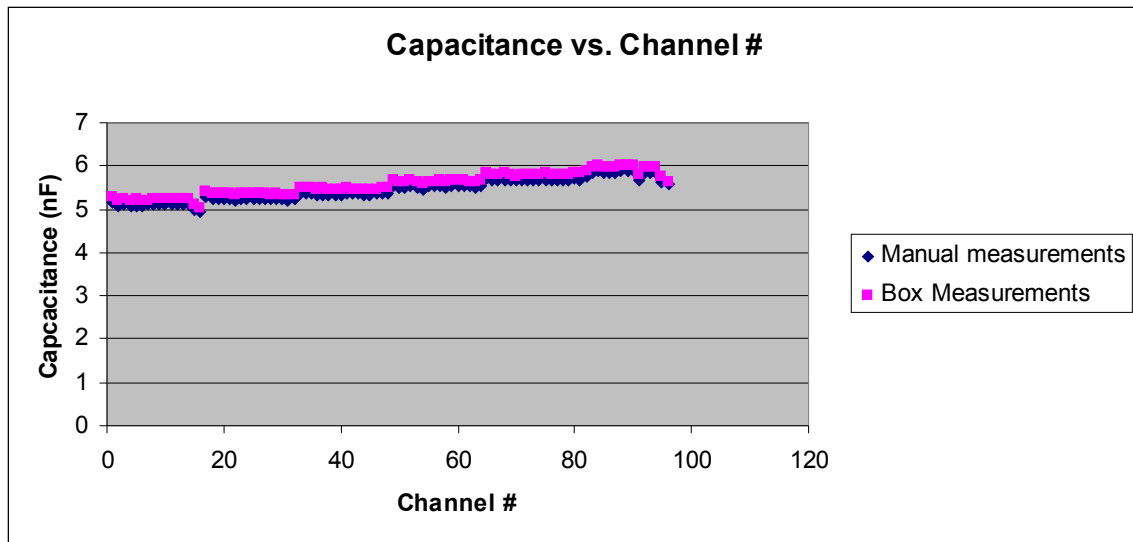
Picture1 2Capacitance vs. Channel #

The graph above shows that our box is working well. The manual data and the box data follow the same pattern for one of the layers measured, except for an additional constant in all measurements in the box data. This graph proves to us that we can take measurements of the remaining 36 planes using the capacitance box. After taking measurements of the remaining 36 planes, I was able to form a loose relationship between capacitance value and the status of the solder joint. The table below describes this relationship, and shows the status of all the solder joints from the 48 Z-planes.

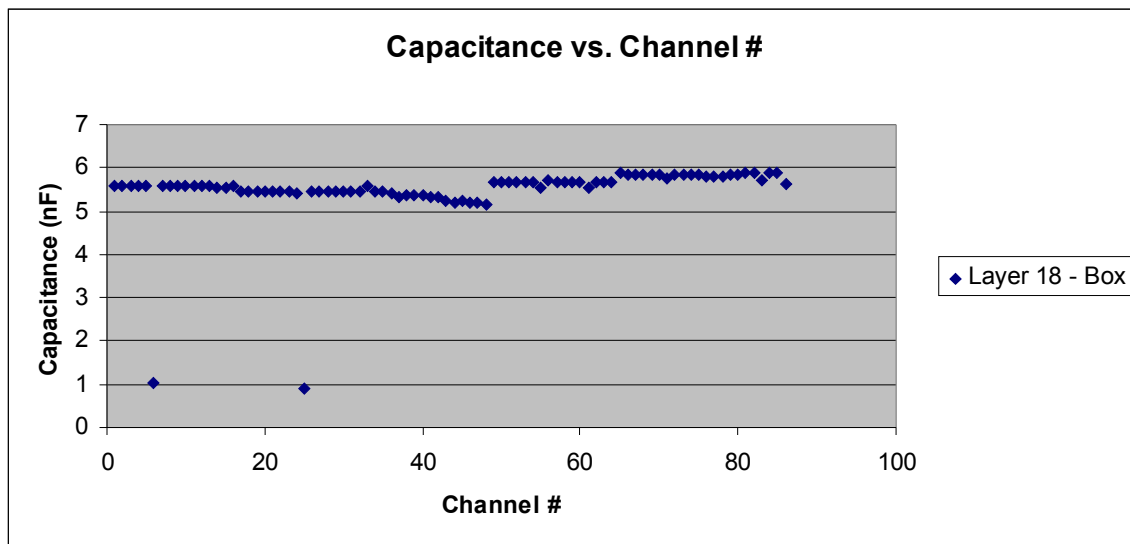
Picture 1 3 Capacitance vs. Channel #

The 5 joints that were loose were easy to find because their capacitance measurement was $C < 2.0 \text{ nF}$. The graph below shows the capacitance measurements of one of the 4 layer 18 Z-planes. This Z-plane had 2 loose solder joints, as seen from this graph:

This graph clearly shows the 2 loose solder joints. These results were verified when we pressed these particular strips near the solder joint, the capacitance suddenly increased, but again decreased when we stopped pressing near the solder joint.
