# Mirror Smooth Surfaces and Repair of Weld Defects in Superconducting RF Cavities by Mechanical Polishing

CA Cooper and LD Cooley

Fermi National Accelerator Laboratory, PO Box 500, Batavia, IL 60510, USA

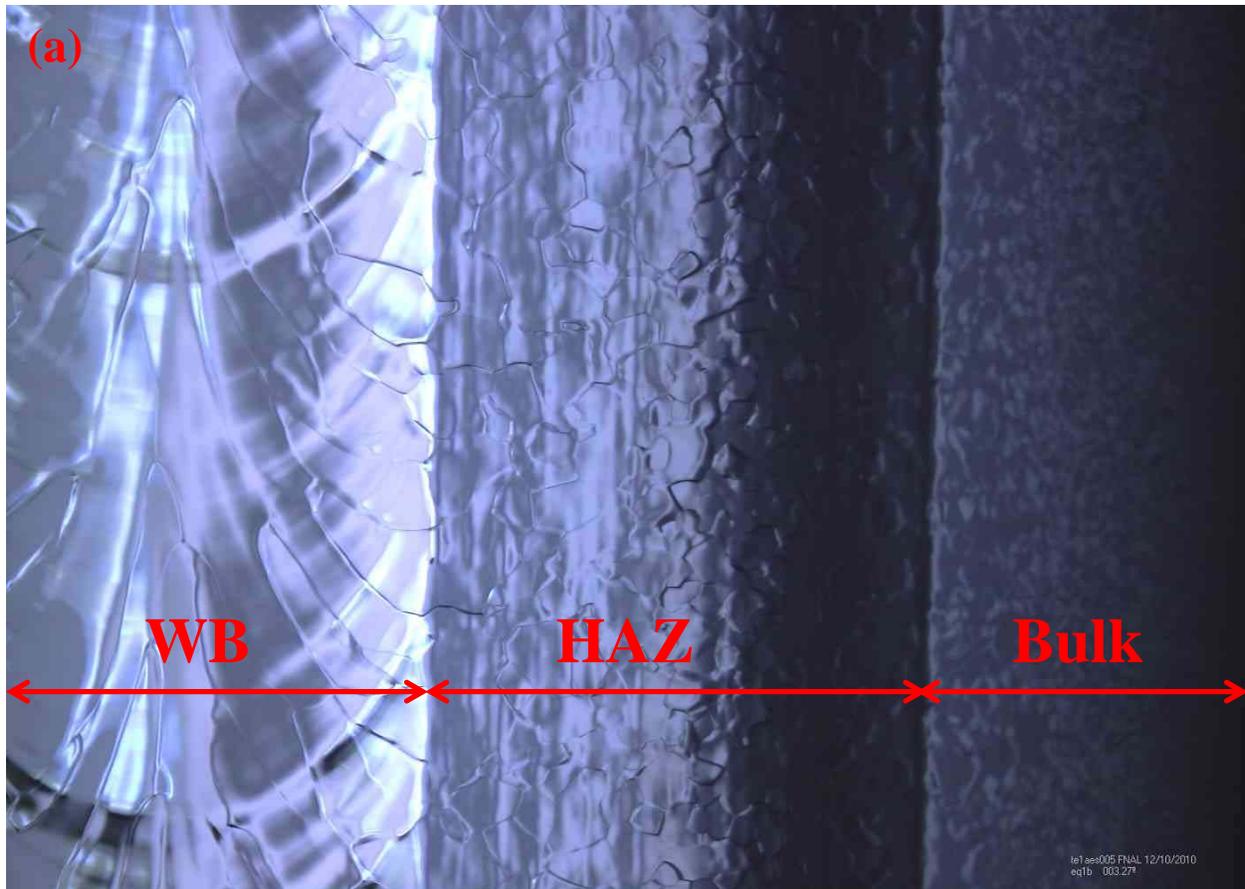
**Figure 1(a).** Figures 1(a), 1(b) and 1(c) are of equatorial weld beads under different processing conditions acquired by a cavity imaging system. In all pictures, WB indicates the extent of the weld bead, HAZ indicates the heat-affected zone, and Bulk refers roughly to unaffected niobium. During the process of weld preparation, some machining takes place to produce the vertical boundaries seen. Figure 1(a) shows TE1AES005 after standard electropolishing. This image is representative of what is seen on many other cavities after a standard EP process.

Figure 1 shows the surface finish obtained by XMP compared to that obtained by a standard EP procedure. Pictures of the equatorial welds were taken by a special camera system [26] designed to access the cavity interior. This system has 20  $\mu\text{m}$  resolution. In all pictures, the weld bead (WB) is approximately 10 mm wide and runs from top to bottom. Adjacent to the weld bead and running parallel to it on either side is a heat-affected zone (HAZ), which is approximately 15 mm wide. The material thickness is reduced prior to welding to control the thickness of the cosmetic under-bead, since the full-penetration weld is made from the outside of the cavity in a horizontal geometry. This standard machining step produces a fairly sharp demarcation at the edge of the HAZ also running parallel to the weld bead. Bulk niobium extends beyond this latter boundary. The entire weld, which runs circumferentially around the cavity equator, was scanned for each cavity. The pictures in Figure 1 represent 3° sections of the full 360° welds, and each is typical of the approximately 120 images acquired. The direction the media moves against the surface is parallel to the weld.

Figure 1(a), 1(b) and 1(c) are from the WB of single cell cavity TE1AES005. Figure 1a shows the cavity after the standard EP treatment. The individual grains are easily distinguishable, with shadowing evident at the grain boundaries. This is indicative of height differences between the grains. The WB, HAZ, and bulk regions can clearly be distinguished, and differences in grain morphology between these regions is also evident. Figure 1(b) is the exact same area as in figure 1(a), but after extended mechanical polishing to a mirror finish. It should be noted that the electropolished surface depicted in figure 1(a) was completely erased by the first 2 steps of mechanical polishing. The surface looks very homogeneous in figure 1(b), and no grain boundaries or demarcations of WB or HAZ are visible. There are tiny scratches running from top to the bottom of the picture that are approximately 20  $\mu\text{m}$  wide. These marks are most likely left from the alumina in the next to last step or the wood blocks used in the final two polishing steps. Figure 1(c) shows the effect of 10  $\mu\text{m}$  of electropolishing on the mirror finish. While grain boundaries reappear in the WB and HAZ, the top-to-bottom marks left by the media are mostly removed. The wide black bands running from top to bottom in figure 1(b) and 1(c) are actually reflections of the light-emitting diode array used for illumination by the camera system.

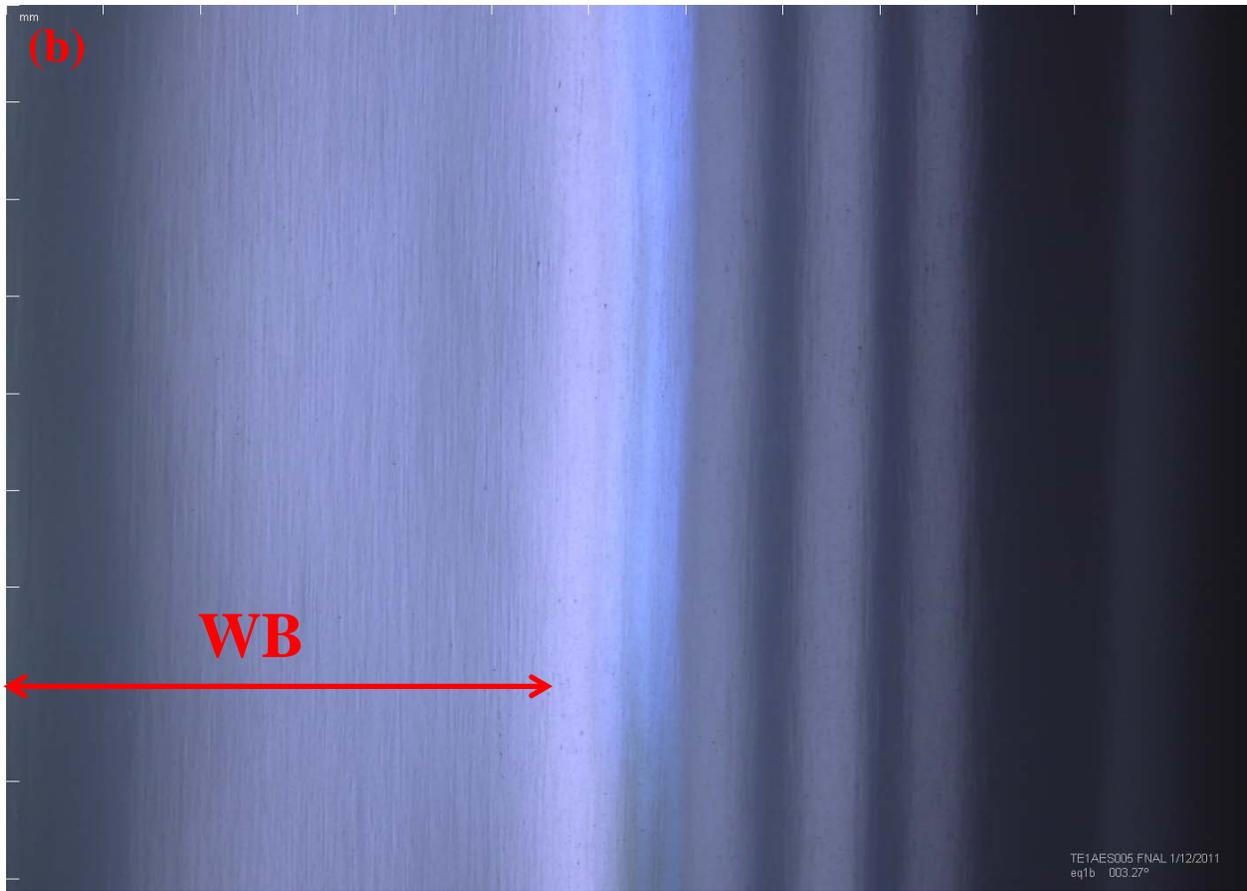
**Figure 1(b)** shows the same area in (a) after extended mechanical polishing to a mirror finish.

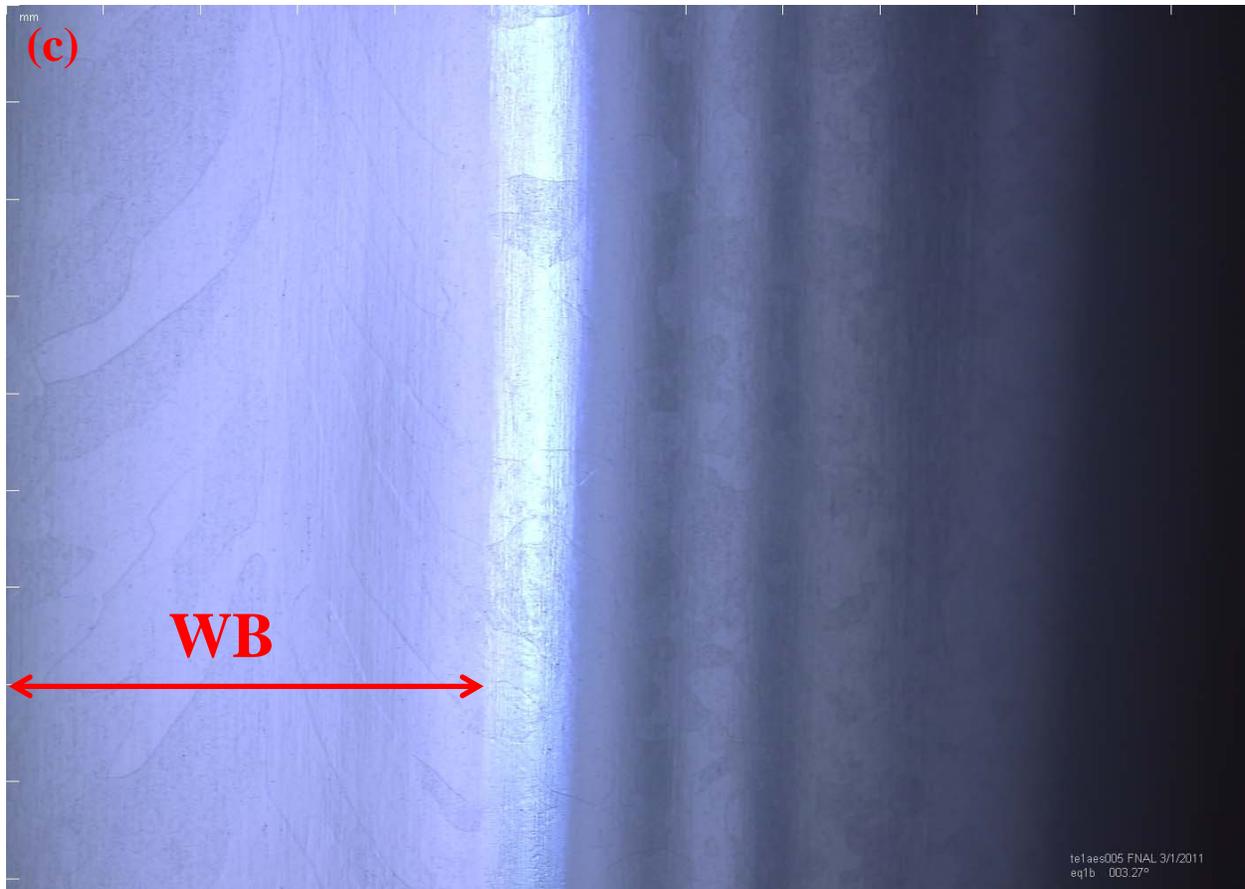
**Figure 1(c)** shows the same area seen in (b) after 10  $\mu\text{m}$  of electropolishing.

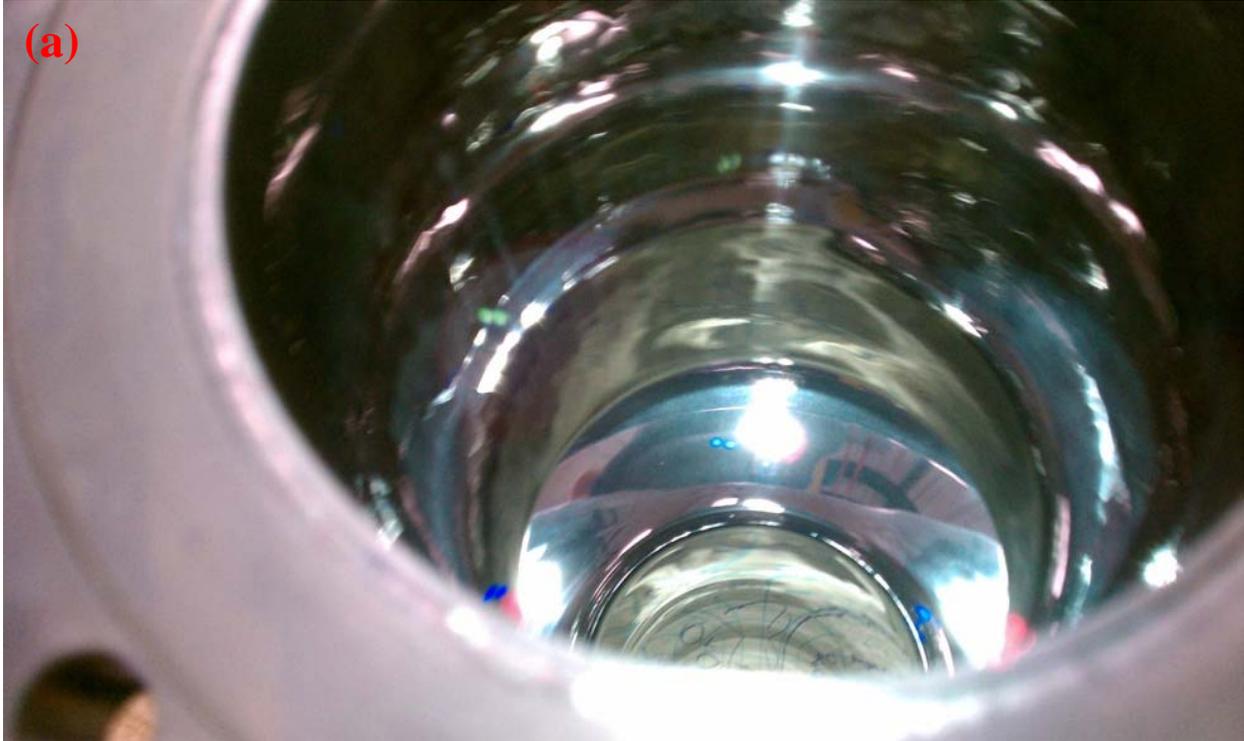
**Figure 2(a).** Pictures taken with a handheld digital camera of a single cell (a) and a nine cell (b) 1.3 GHz Tesla-type cavity after centrifugal barrel polishing to a mirror finish. The single cell cavity is standing on end on a piece of graph paper and the curved reflection of the grid can be seen in the cavity.

Even more dramatic, Figure 2 shows a picture of a single cell cavity and a nine cell cavity taken with a digital camera viewing through the end flange. The appearance of these cavities is impressive because of the mirror finish and the high number of reflections of light. The mirror finish makes the surface itself difficult to photograph because there are so few edges or other features to focus on. If Figure 2(a) is examined closely, an overhead crane can be seen in the reflection (the 2 orange rails). There is also the reflection from a piece of graph paper on the cavity, where the surface finish is smooth enough to distinguish the grid pattern distorted by the round geometry of the beam tube. Figure 2(b) shows a picture of a nine cell cavity that also has a mirror finish. Blue cellophane was placed in front of the light source to try to cut down on some of the reflection.

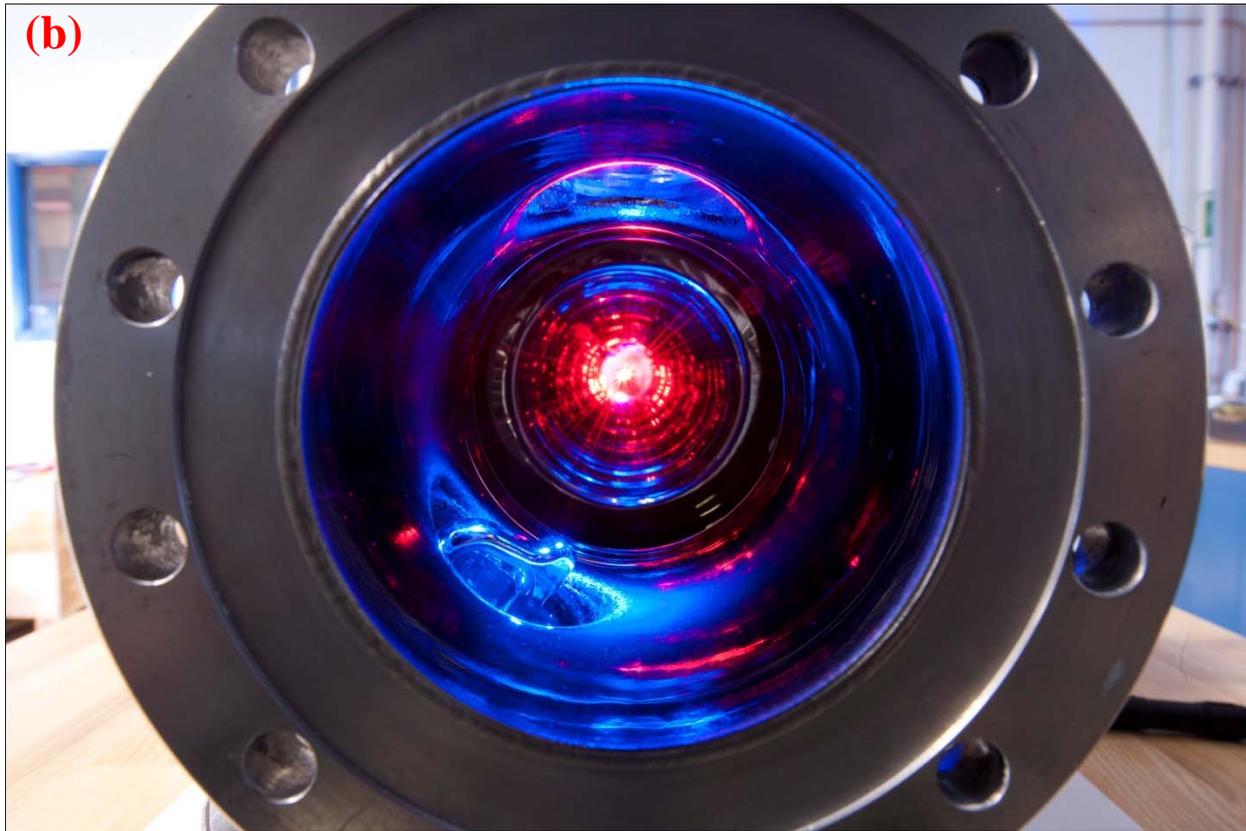
**Figure 2(b).** Picture taken of a 9-cell Tesla-type cavity after centrifugal barrel polishing to a mirror finish. Blue cellophane was placed over the light source to cut down on glare and a red light source was shown through the opposite end.

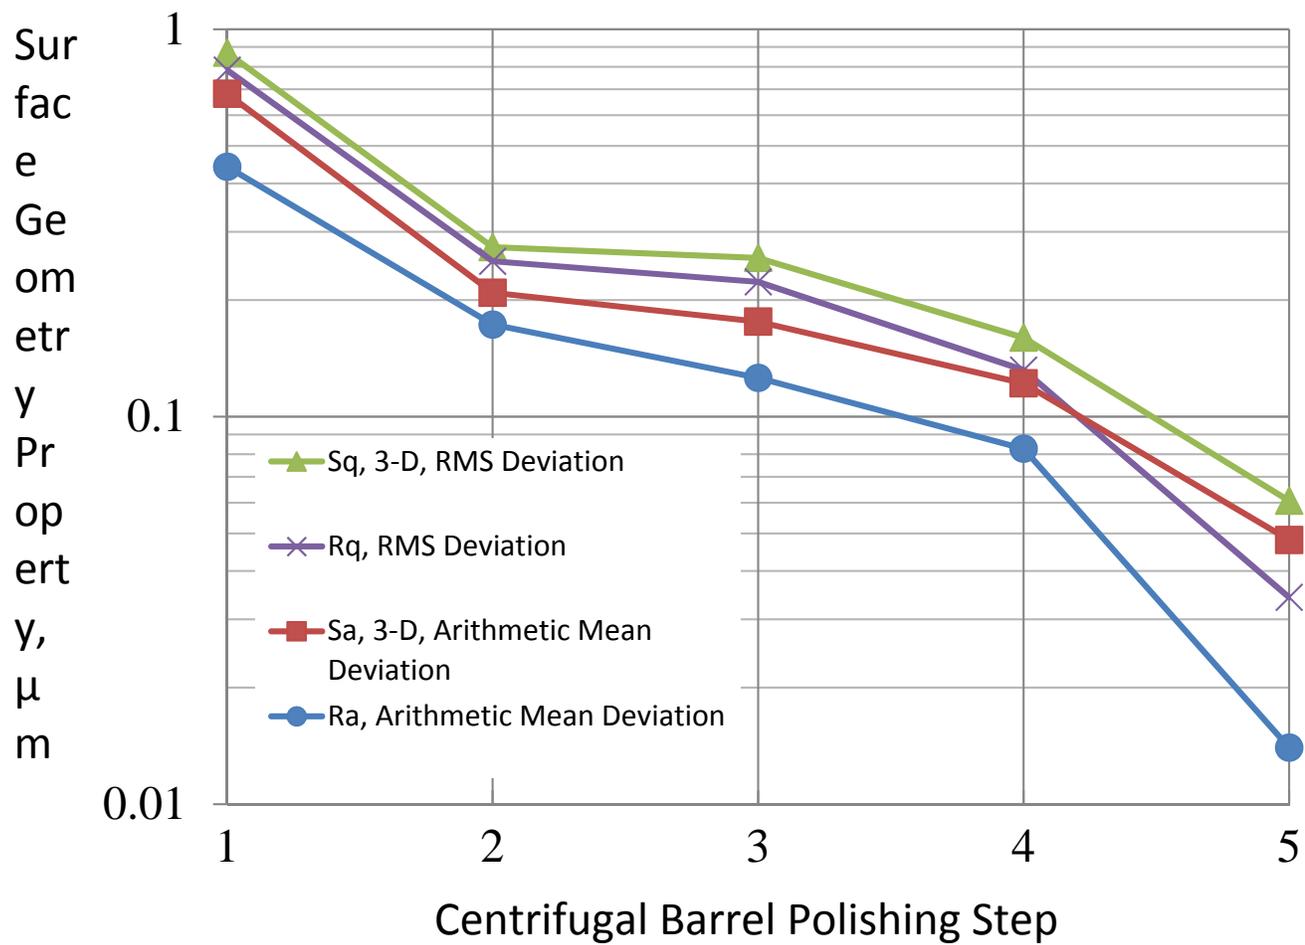
**Figure 3.** Is a graph of the RMS deviation and arithmetic mean data obtained from the surface profilometer after centrifugal barrel polishing with each one of 5 different media. Sample size is 1 mm with scans taken 1 micron apart and data points take every micron.

Figures 3 and 4 show the effect of each of the 5 different media on the surface of the niobium end plate used to cap the cavities during XMP. Figure 3 plots the RMS deviation ( $R_Q$ ,  $S_Q$ ) and arithmetic mean deviation ( $R_A$ ,  $S_A$ ) for the sample after each XMP step.  $S_Q$  and  $S_A$  are values for the entire 1 mm by 1 mm surface scan (3D values), while  $R_Q$  and  $R_A$  are values for 1 mm long lines extending across the scan area (2D values). The  $R_Q$  and  $R_A$  values are the average of 1000 lines spaced 1  $\mu\text{m}$  apart. No error bars are shown because they lie within the data markers on the graph. All the parameters show the same general trend, with large decreases in values produced by the sequence from step 2, the first polishing step, to step 5, polishing with colloidal silica. The  $R_A$  is decreased finally to 14 nm and the  $S_A$  to 48 nm. These values are significantly less than the 0.1  $\mu\text{m}$   $R_A$  values typically obtained by EP [3,4]. The maximum peak height  $R_P$ , maximum valley depth,  $R_V$ , and total height  $R_T = (R_P + R_V)$  are also useful 2D statistics to help characterize the effects of XMP on the surface. Figure 4 shows a plot of these values after each step along with  $S_T$ , the 3D total height of the surface.  $S_T$  decreased from 9.6  $\mu\text{m}$  to 1.6  $\mu\text{m}$  during polishing. However, since the plane of the sample is not flat, the profilometer algorithm probably over-estimates the final  $S_T$  value.

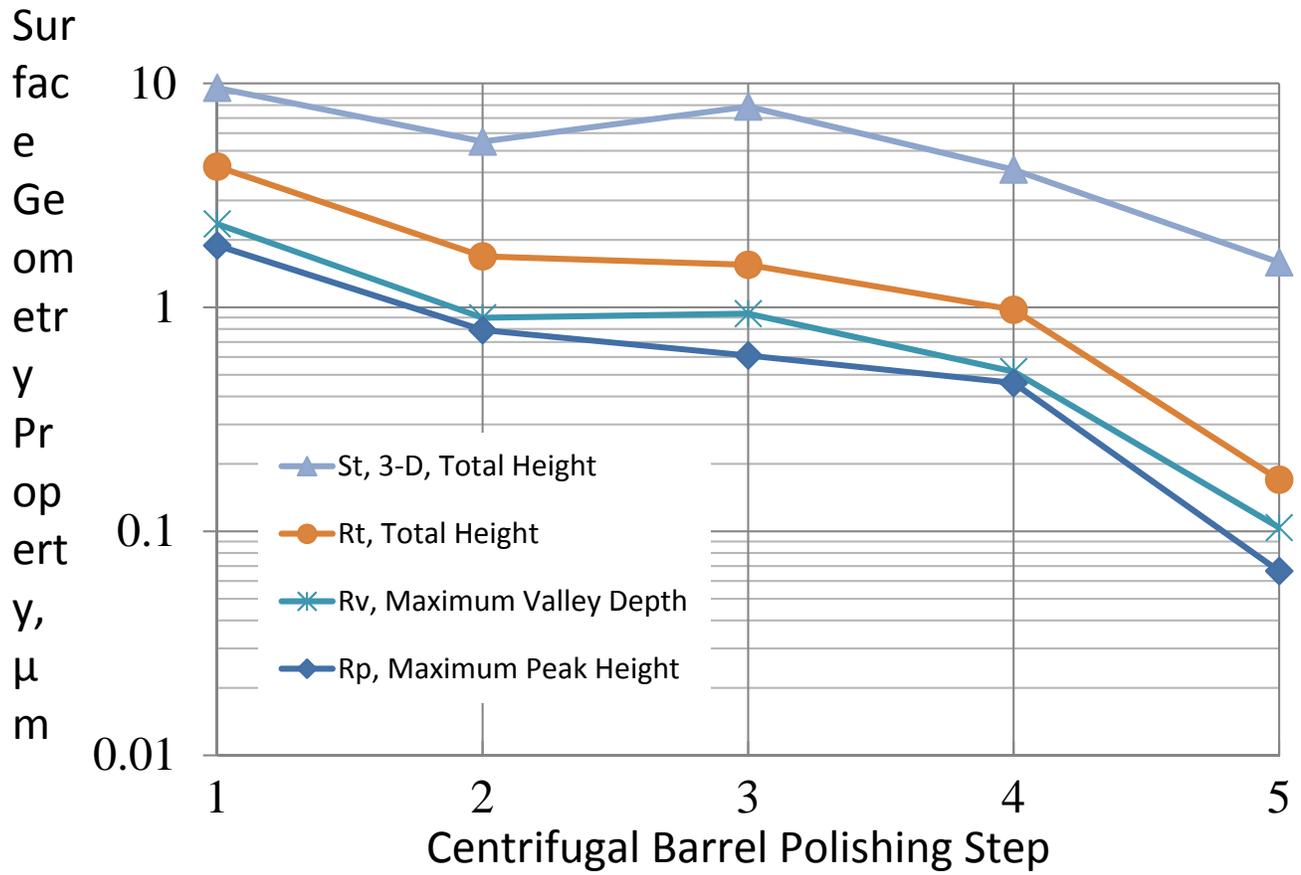
**Figure 4.** Is a graph of the maximum peak height and valley depth obtained from the surface profilometer after centrifugal barrel polishing with each one of 5 different media. Sample size is 1 mm with scans taken 1 micron apart and data points take every micron.

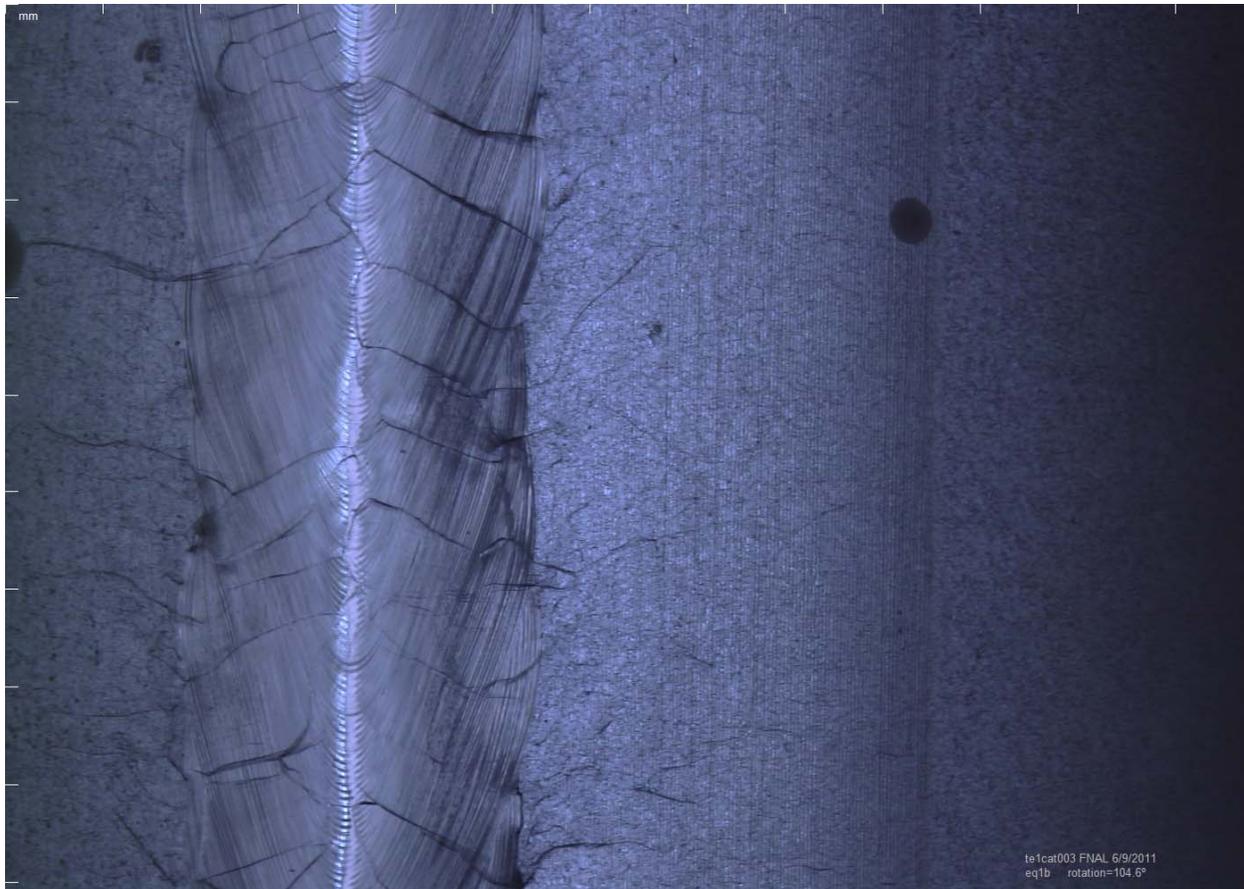
**Figure 5 shows pictures of the equator electron beam weld area of single cell cavity RRCAT003. The large black dot is believed to be an inclusion, possibly of aluminum. Figure 5(a) shows a defective spot on the cavity after manufacturing. Figure 5(b) shows the cavity at the same spot after the baseline electropolishing technique. Figure 5(c) shows a different spot on the same cavity after manufacturing. Figure 5(d) shows the same area seen in 5(c) but after the baseline processing technique. Figure 5(e) shows the cavity after the XMP process. The picture shown in Figure 5(e) is at the same spot as the defect seen in Figure 5(a), but it is representative of the entire weld.**

In addition to being able to remove pits or voids, XMP can remove metal flakes and inclusions. These types of defects can also be resistant to EP. Figure 5 shows multiple pictures of 2 defective areas near the weld bead region of cavities RRCAT003. Figure 5(a) and 5(c) were acquired just after manufacturing with and before any chemical processing. Both pictures have a single nondescript black dot that is on the order of 1 mm in diameter. Figure 5(b) and 5(d) show the same areas as in 5(a) and 5(c), respectively, after bulk EP. The black feature appears to have not been affected by EP, and figure 5(d) in particular shows that there is a heavily etched “trench” around the location of the feature but little apparent effect on the inclusion itself. Since the forming die is made from aluminum, and aluminum is not affected by EP, it was concluded that this may be an aluminum flake, although confirmation of this hypothesis would require destruction of the cavity. Figure 5(e) shows the same area as 5(a) and (c) but after the XMP process. The surface is very homogeneous with no signs of the defect left behind.

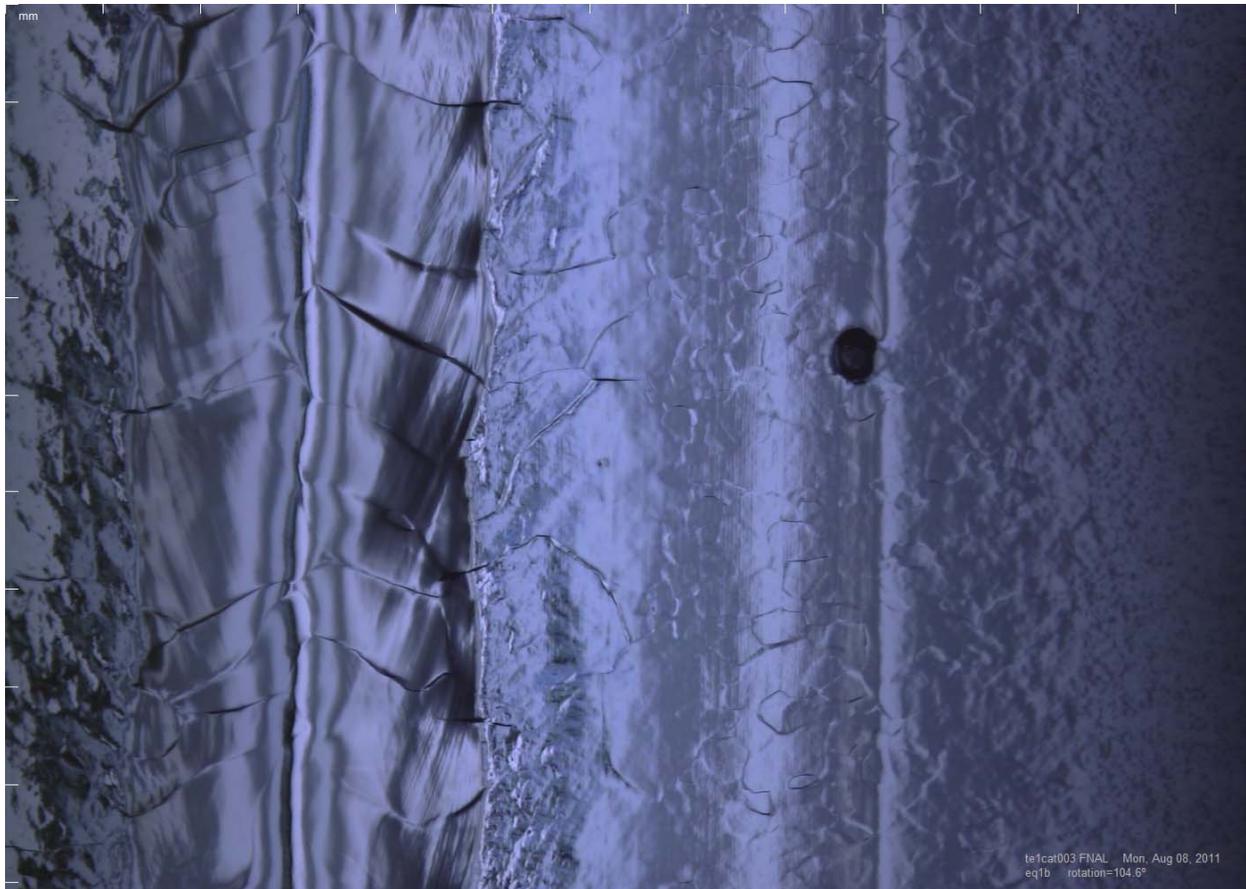
**Figure 5(b) shows the cavity at the same spot after the baseline electropolishing technique.**

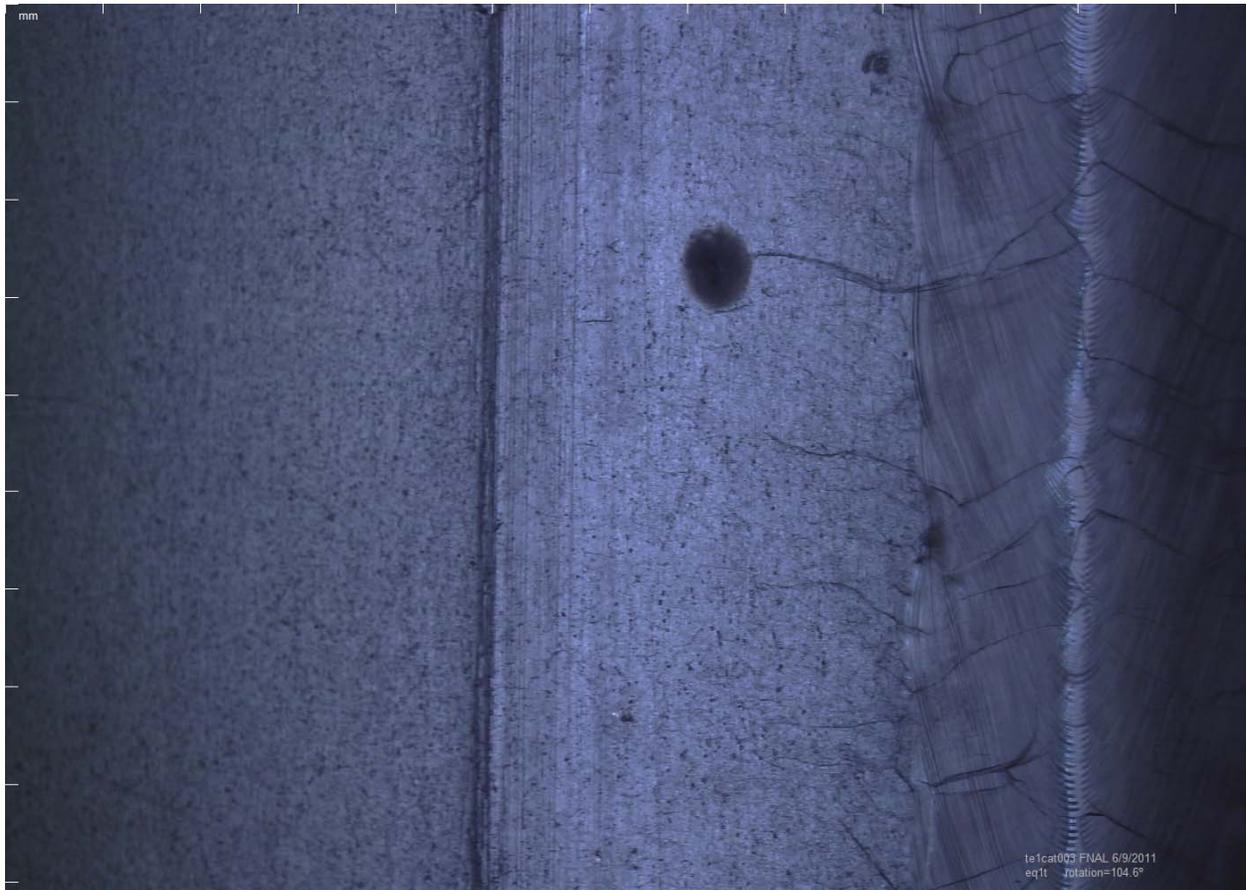
**Figure 5(c) shows a different spot on the same cavity after manufacturing.**

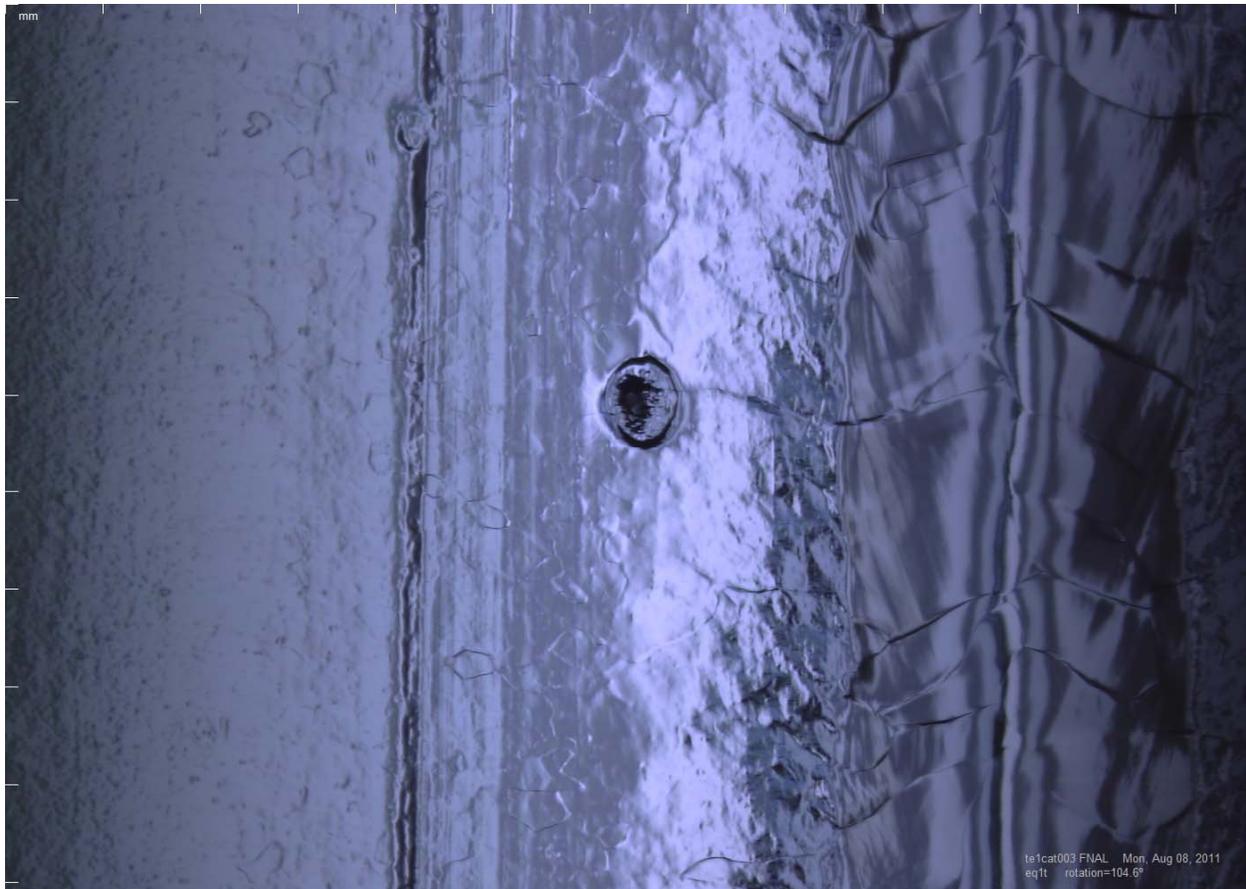
**Figure 5(d) shows the same area seen in 5(c) but after the baseline processing technique.**

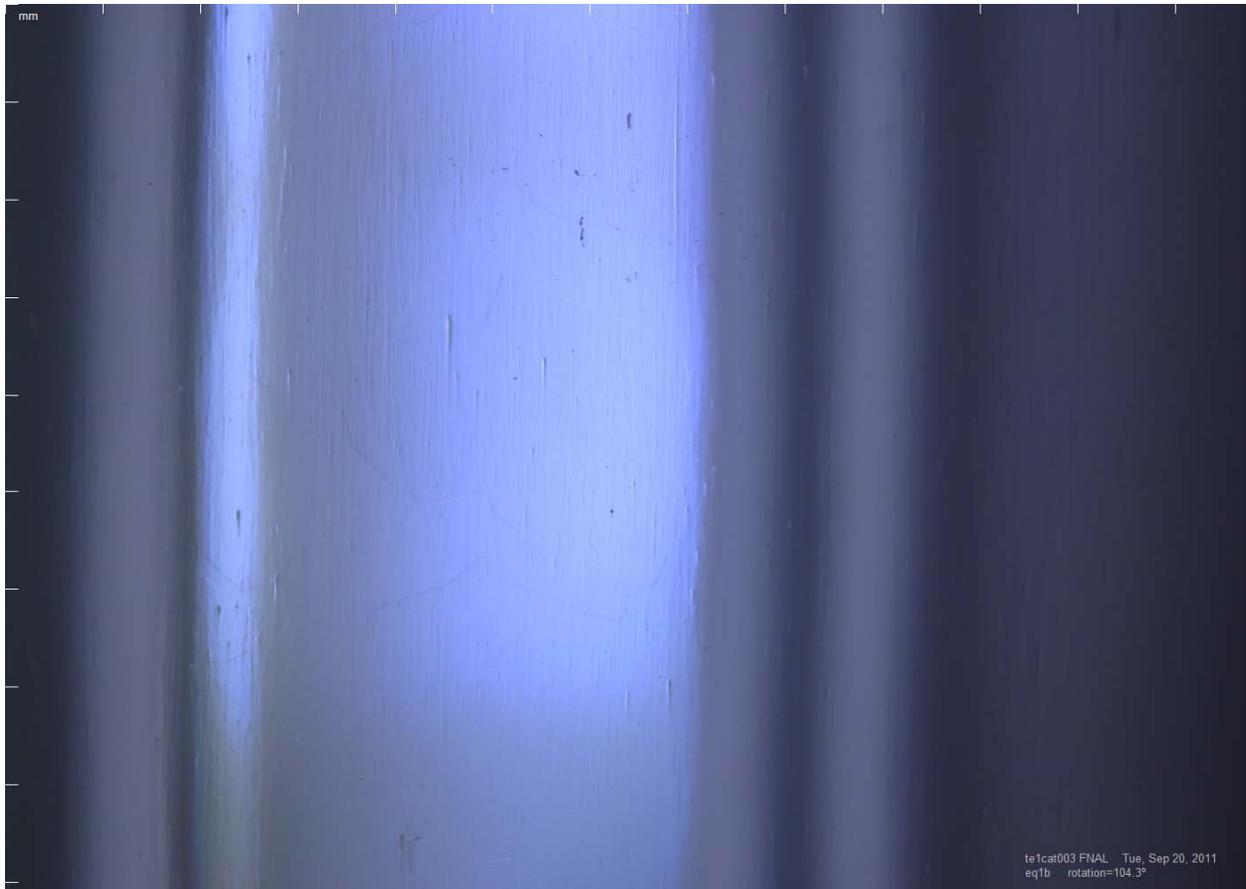
**Figure 5(e) shows the cavity after the XMP process. The picture shown in Figure 5(e) is at the same spot as the defect seen in Figure 5(a), and is representative of the entire weld.**

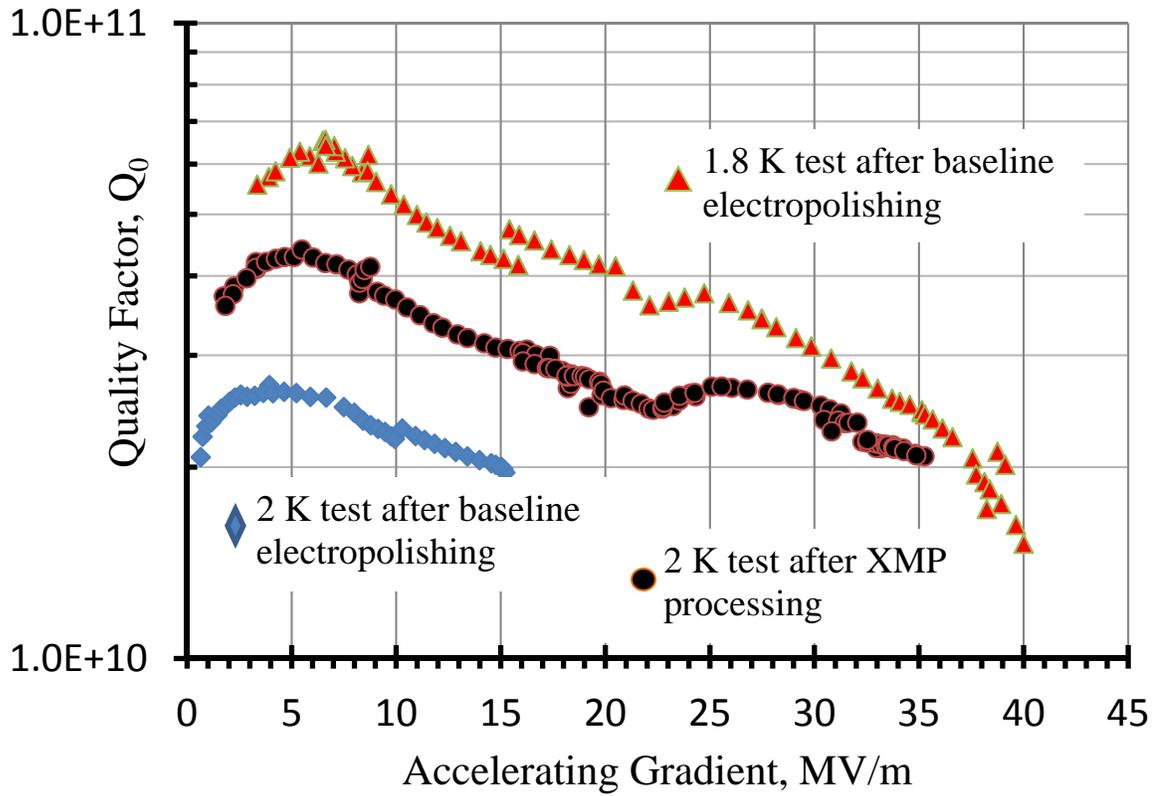
Figure 6 shows the accelerating gradient in MV/m versus the quality factor for single cell 1.3 GHz cavity RRCAT003 after baseline electropolishing (blue diamonds) and after XMP (black circles). Both tests are at 2 K. The red triangles are the results of the cavity after XMP and tested at 1.8 K.

The effect of XMP on the performance of RRCAT003 can be seen in Figure 6. Figure 6 shows a graph of the accelerating gradient of the cavity versus the quality for the cavity after baseline processing with electropolishing and after processing with XMP. At 2 K the accelerating gradient improved from 15 MV/m to 35 MV/m after the XMP process. At 1.8 K the cavity reached 40 MV/m after the XMP process. The XMP process in this instance demonstrates the ability to overcome some major manufacturing defects, which could not be repaired by electropolishing to yield a high performing cavity.

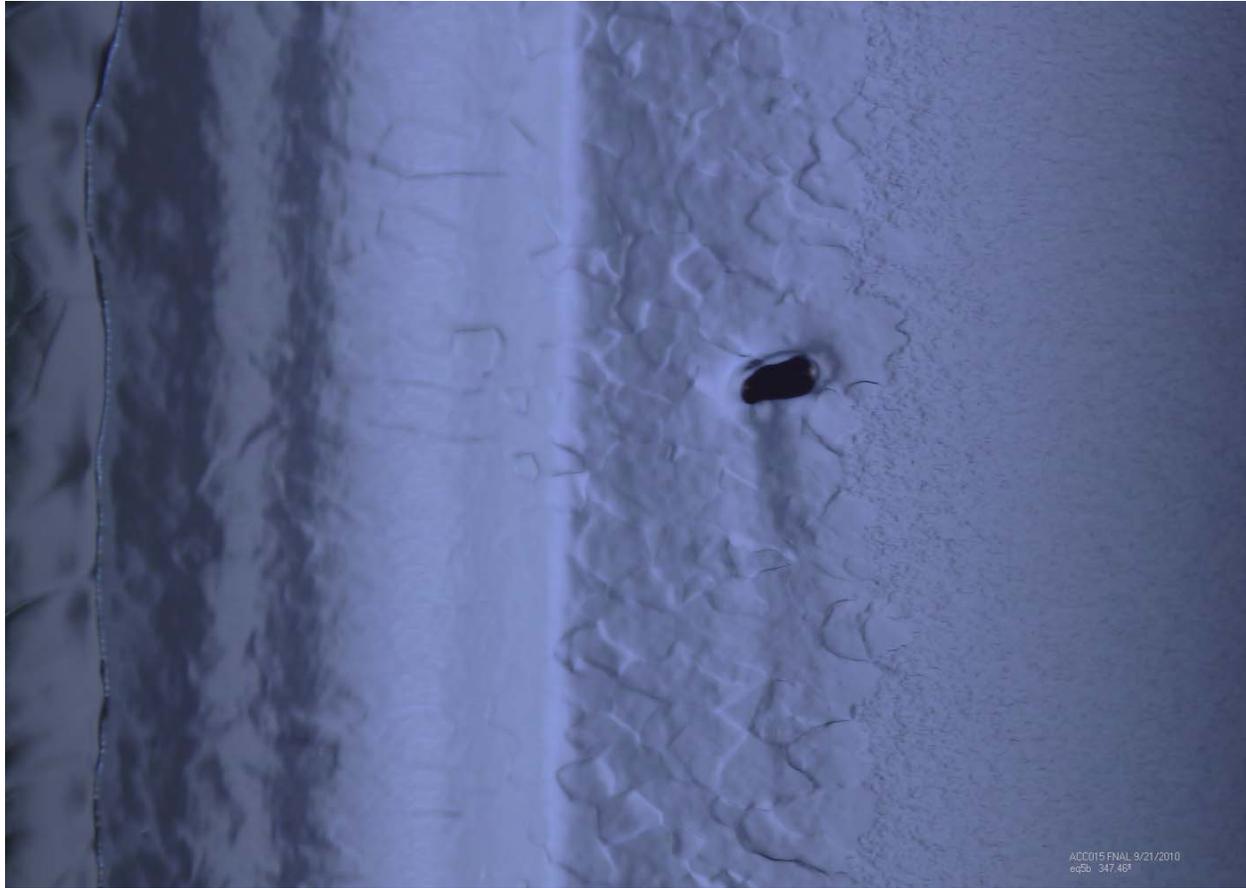
**Figure 7(a) shows a picture of the weld area of cavity TB9ACC015. There appears to be a large inclusion that was not removed by the standard electropolishing process.**

Figure 7(a) shows the surface of the 9-cell cavity TB9ACC015 after the cavity had received bulk EP as part of the standard cavity polishing regimen. An obvious defect is visible. This defect looks very similar to those shown from RRCAT003. After cold testing with this defect the cavity performed very poorly, reaching approximately 19 MV/m with a quench initiated in this cell by the defect. Subsequently, the first 4 steps of the extended mechanical polishing process were applied to remove 120  $\mu\text{m}$  of metal, followed by 60  $\mu\text{m}$  of EP. Figure 7(b) shows no sign of the pit at its earlier location. After mechanical polishing to an intermediate finish followed by EP the cavity reached 35 MV/m with a quality factor above  $2 \times 10^{10}$ . The quality factor, shown in Figure 8, showed little degradation with increasing gradient and was  $1.4 \times 10^{10}$  at 35 MV/m in fundamental mode, thus reaching the qualifying gradient for the International Linear Collider ( $Q > 8 \times 10^9$  at 35 MV  $\text{m}^{-1}$ ).

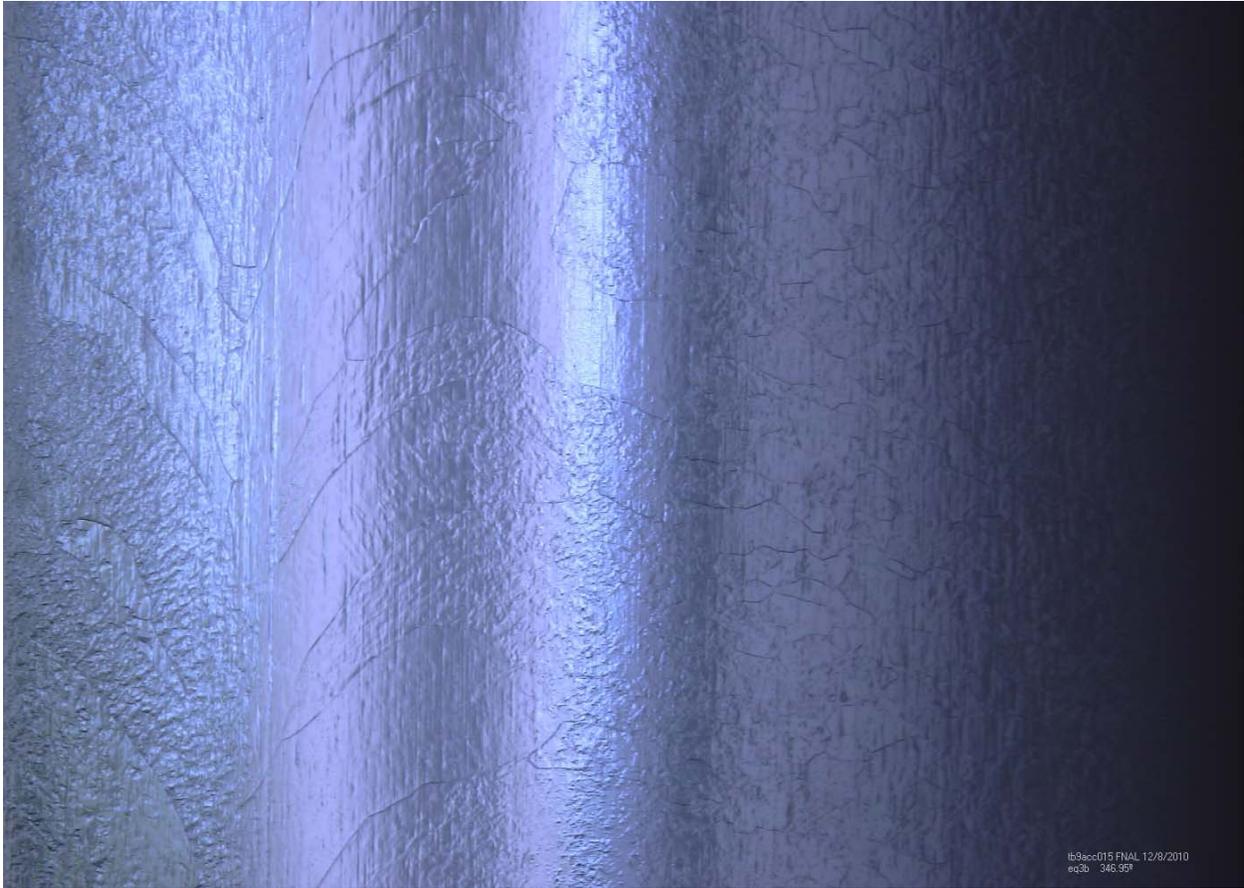
**Figure 7(b) shows the same area as seen in Figure 7(a) but after centrifugal barrel polishing to an intermediate finish followed by a 60 micron electropolish. No sign of the defect remains.**

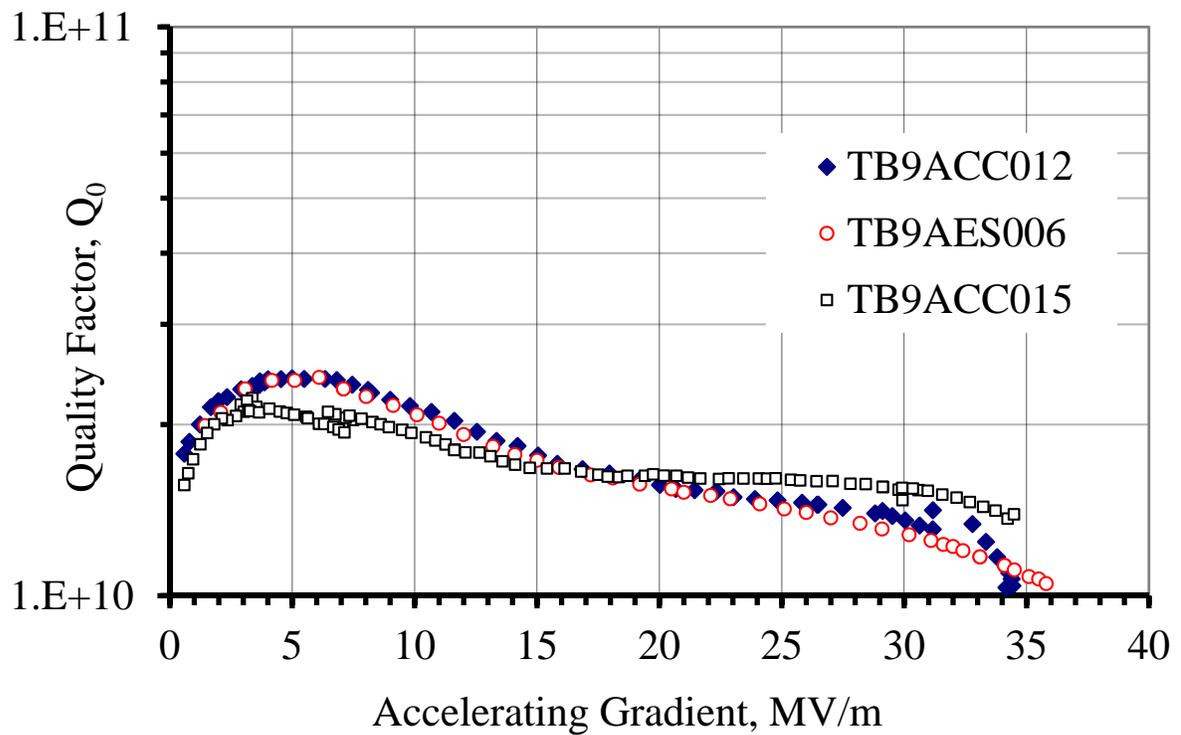
Figure 8 shows the 2 K performance results of various 9-cell cavities repaired by XMP. TB9AES006 and TB9ACC015 both had large defects and only performed at 19 MV/m before processing via XMP. TB9ACC012 was processed via electropolishing and then had the last 1 and 1/2 cells and end group replaced before processing before XMP. When testing under different Pi modes all cells in TB9ACC012 tested between 39 to 41 MV/m except the 2/8 cells due to the repair technique prior to XMP.

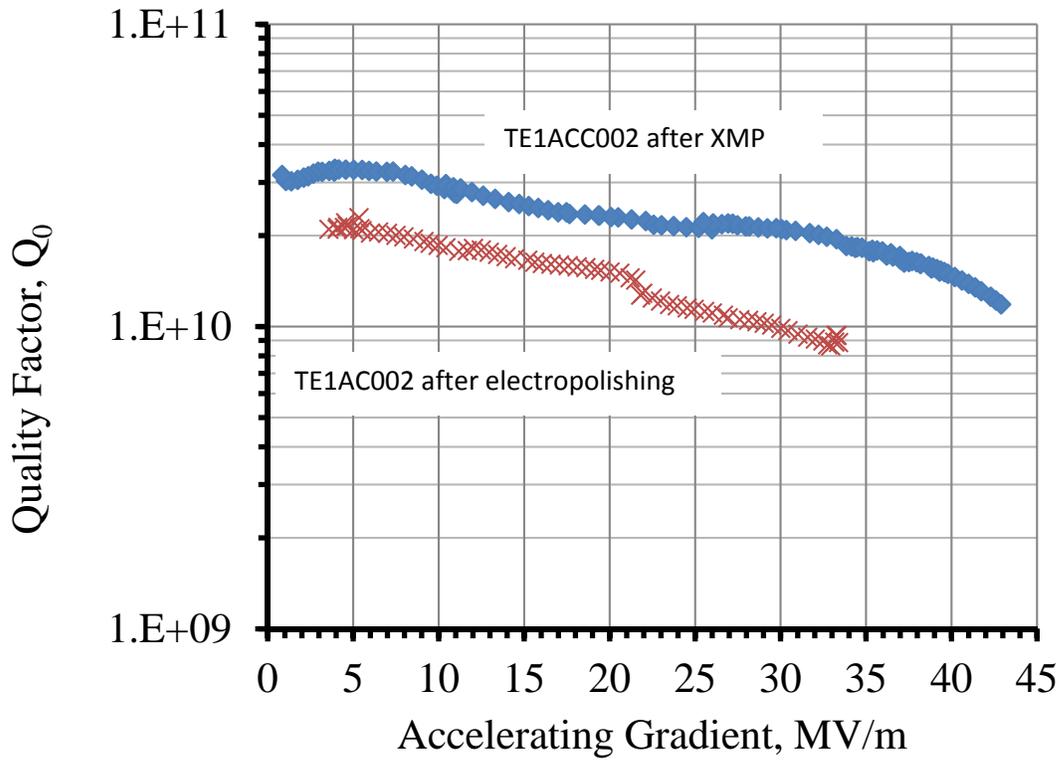
**Figure 9** shows the improvement in performance data of single cell cavity TE1ACC002 in the form of accelerating gradient versus quality factor for the cavity after baseline processing with electropolishing (below) and after XMP (above). Tests were done at 2 K.

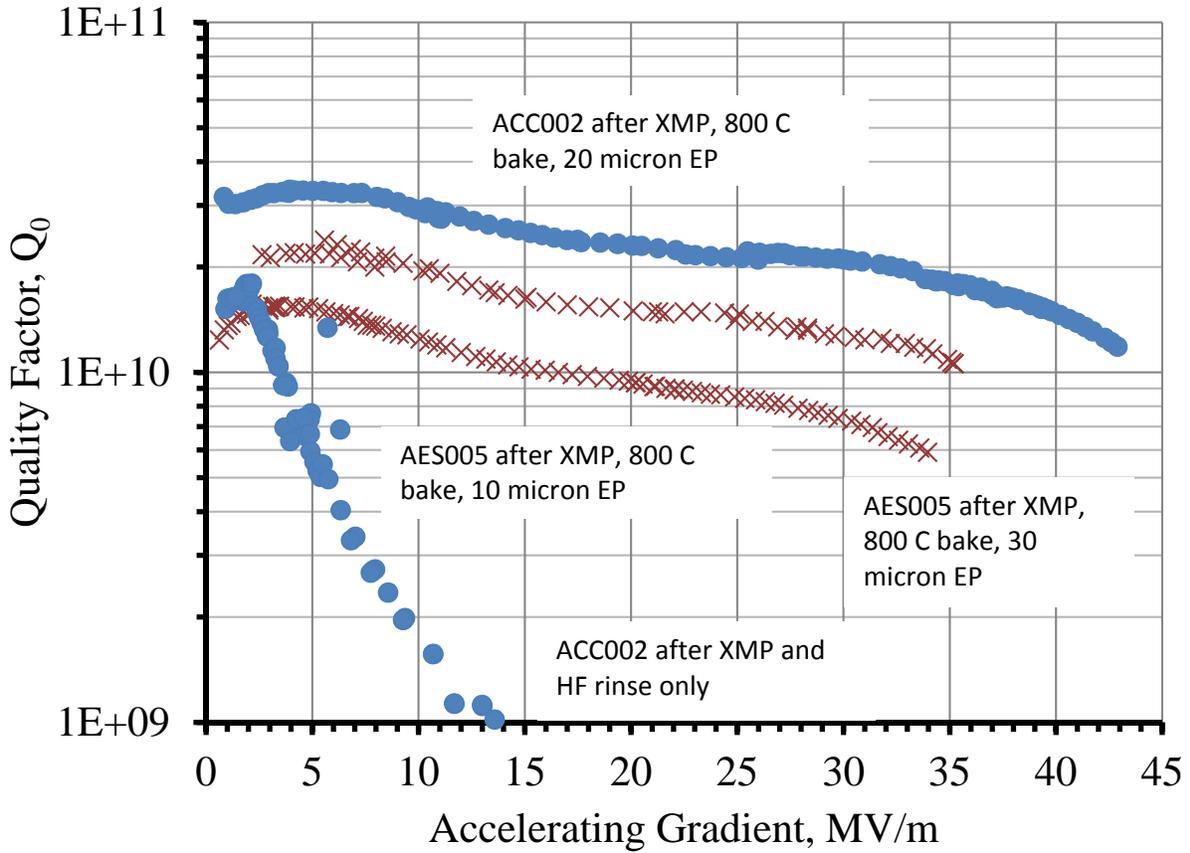
Figure 10 shows the 2 K quality factor versus accelerating gradient data for two different single cell cavities with varying amounts of post XMP chemistry. Both are single cell cavities that were polished to a mirror finish by XMP. The data shows that after 20 microns of chemistry the damage layer left from XMP is removed.
