# THE BEAM CLEANING ANALYSIS FOR THE TPS VACUUM SYSTEM

Y. C. Yang<sup>†</sup>, C. K. Chan, A. Y. Chen, C. H. Huang, J. -Y. Chuang, C. -C. Chang,  
National Synchrotron Radiation Research Center (NSRRC), Hsinchu 30076, Taiwan, R.O.C.

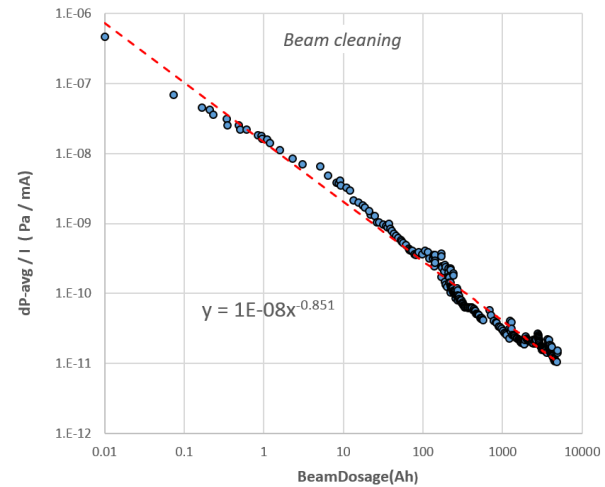
Figure 1: Evolution of the dynamic pressure in the TPS storage ring.

The evolution of beam cleaning in the TPS storage ring is shown in Fig.1, where the average pressure raise per beam current ( $dP\text{-avg}/I$ ) versus accumulated beam dose (Ah) is plotted and is showing a scaling with an exponent of -0.85. Until the last machine shut down in December 2018, a total beam dose of 4919 Ah was accumulated and the dynamic pressure,  $dP/I$ , decreased to  $1.5 \times 10^{-11}$  Pa/mA and to  $1.63 \times 10^{-8}$  Pa with a beam current of 500mA.

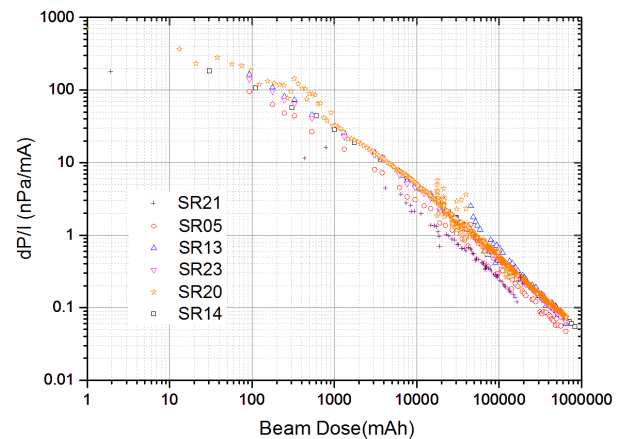
Figure 2: Beam cleaning process for six new vacuum sections.

The local dynamic pressure versus accumulated beam dose for six replaced vacuum sections with different beam commissioning periods are plotted and compared in Fig. 2. Each vacuum section corresponds to separate insertion devices with different power densities inducing different pressure readings. In general, the value of  $dP/I$  decreases continuously with accumulated beam dose. The goal of the beam cleaning process is to accumulate a high beam dose as fast as possible to get lower values for  $dP/I$ .

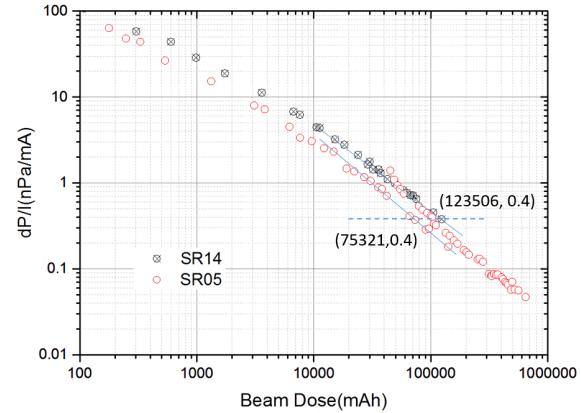
Figure 3: Comparison of  $dP/I$  with different pumping speeds.

Another way to decrease  $dP/I$  values is to increase the pumping speed. One extra pump was installed near crotch absorbers downstream of the bending chamber in section SR05 to increase the pumping speed. An additional non-evaporable getter (NEG) pump was added to replace the turbo pump originally installed here. The evolution of  $dP/I$  of SR14 and SR05 are compared in Fig. 3. Two trend lines in section SR05 were found, which come from bending magnet contributions and a combination of bending and insertion device power. Compared with the same condition for only bending magnet power, the value of  $dP/I$  in section SR05 with higher pumping speed, reaches a value of 0.4 nPa/mA after only 75321 mAh beam dose whereas a beam dose of 123506 mAh was needed to get the same value in section SR14. The 48485 mAh beam dose difference was due to the NEG pump,

which was equivalent to 120hrs at a beam current of 400mA.

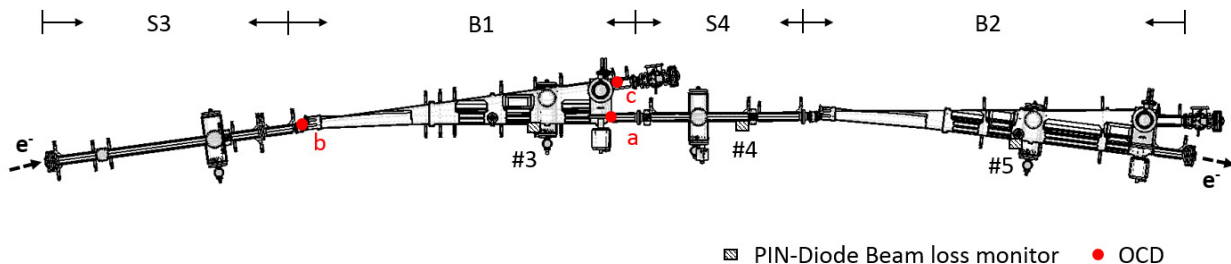
Figure 4: Distribution of beam loss monitors and radiation dosimeters in section SR14.

We expect that a higher vacuum pressure produces a higher beam loss or higher radiation dose rate. Two types of detectors were used to observe the beam loss distribution and mechanisms during SR14 beam cleaning commissioning. The locations of the beam loss detectors are marked in Fig. 4, where two straight vacuum ducts (S3, S4) and one bending chamber (B1) were replaced, while the B2 chamber stayed the same during the chamber upgrade. Opti-chromic dosimeters (OCDs) and PIN-Diode beam loss monitors (MLMs) are standard detectors used in the TPS machine and in many other facilities.

Bergoz's PIN-diode beam loss monitors (BLMs), located on inner vacuum chamber walls are also shown Fig. 4. Three monitors, BLM#3 in B1, BLM#4 in S4 and BLM#5 in B2, were compared during beam cleaning. Higher BLM counting rates during machine

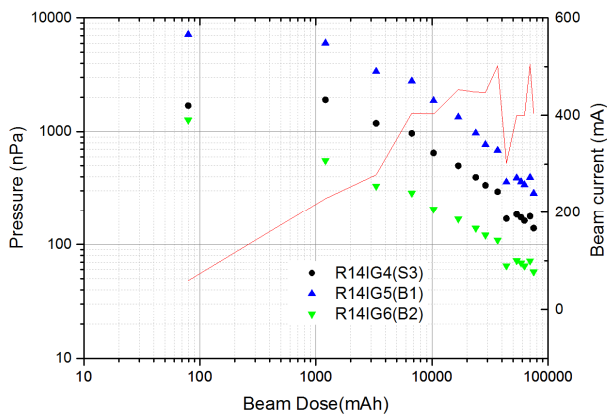
Figure 5: Pressure evolution during beam commissioning in section SR14.

In section SR14, the vacuum pressure readings with 400mA beam current were 5.46 nPa in S3, 6.20 nPa in B1 and 7.77 nPa in B2 before machine shut down in June 2018. After chamber replacement, the pressures rise to 1684.3 nPa, 7161.6 nPa and 1251.1 nPa with only 60mA beam current at the beginning of beam cleaning and dropped to 151.6 nPa, 371.8 nPa and 61.4 nPa with 400mA beam current at the end of commissioning, which is still 8-60 times larger than under the last normal operation conditions. Until December 2018, before the next machine shutdown, these pressures were recovered to original level with 1225 Ah accumulated beam dose. The whole pressure evolution during beam commissioning is displayed in Fig. 5.

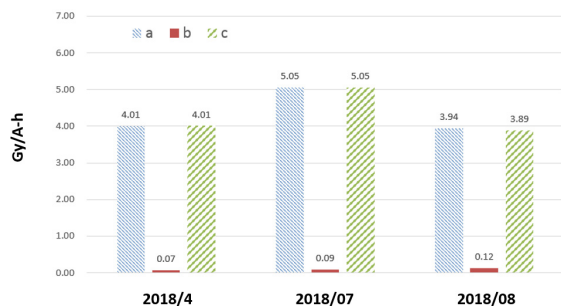
Figure 6: Comparison of OCD dose rates for normal operation and beam commissioning.

The OCD (FWT-70-40M) is a small dye made of aminotriphenyl-methane, which has good linearity in the range of 10 Gy to 10 kGy [2]. Three OCDs, mark (b) located upstream and mark (a) and (c) downstream of the B1 chamber, were compared between normal operation and beam commissioning. The distribution of the radiation dose during normal operational conditions shows a higher radiation dose downstream of the bending chamber produced by bending magnet radiation. During beam commissioning, no big differences were found compared to normal operation even though the vacuum pressure was 2-3 orders of magnitude higher. Monthly data were compared and are shown in Fig. 6, where beam commissioning started from July.

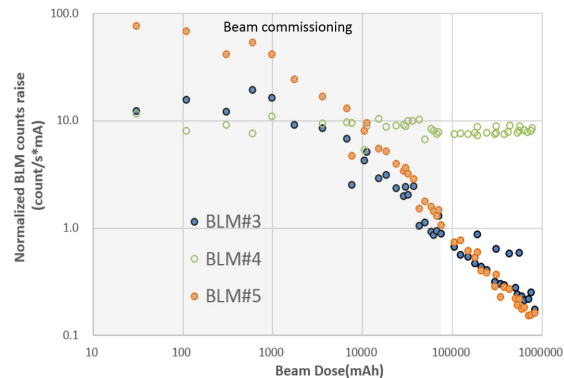
Figure 7: Normalized counting rates of the BLM decreased due to the vacuum pressure improvement.

commissioning was observed, especially in new chambers with elevated vacuum pressures [3]. The high counting rate is due to inelastic Coulomb scattering of electrons with residual gas atoms as detected downstream of the new vacuum sections. This is why the counting rate of the BLM#5 was higher than that of BLM#3 even through the pressure in the B1 vacuum chamber was higher than in the B2 chamber. From the data shown in Fig. 7, the normalized counting rates of BLM #3 and #5 decreased as a result of the vacuum pressure improvement whereas the BLM#4 was saturated due to exposure to bending magnet radiation which was solved by lead shielding.
